ANNUAL COMPLIANCE REPORT

(Combined Approval 60CA581273)

2023/24

LICENCE COMPLIANCE REPORT 2023/24

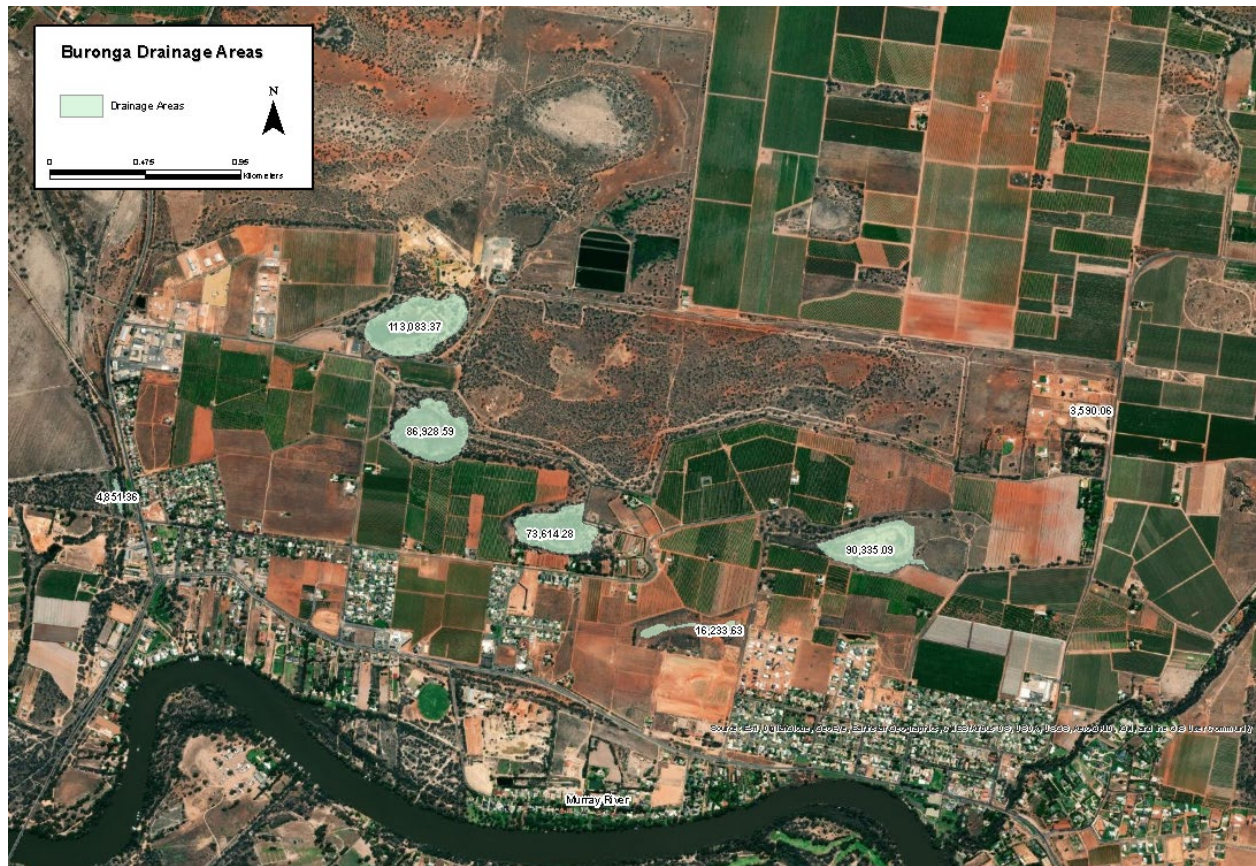
Buronga - Extent of area (square metres) that are temporarily inundated to store drainage and storm water (evaporation basins).

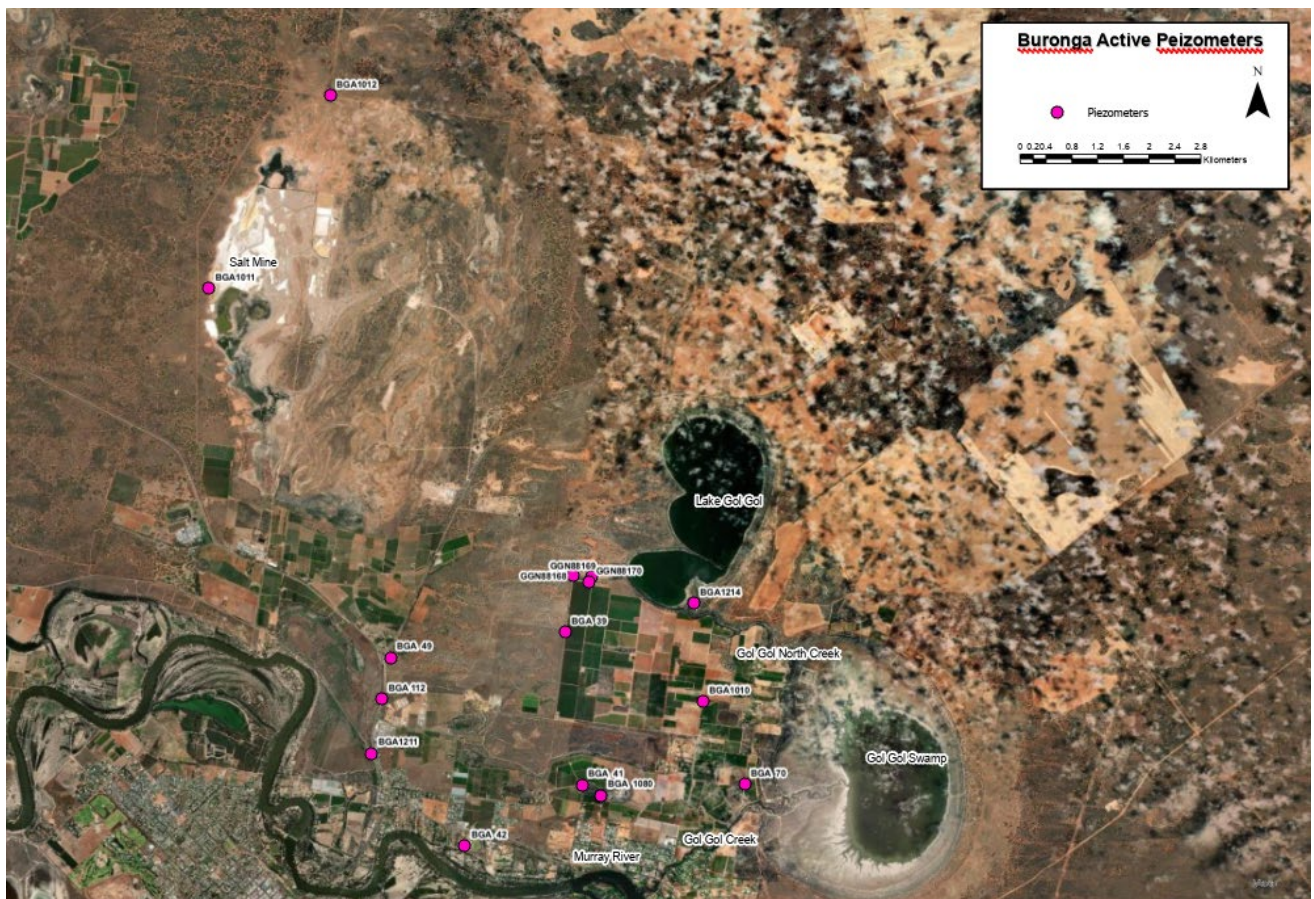
Buronga Active Piezometers

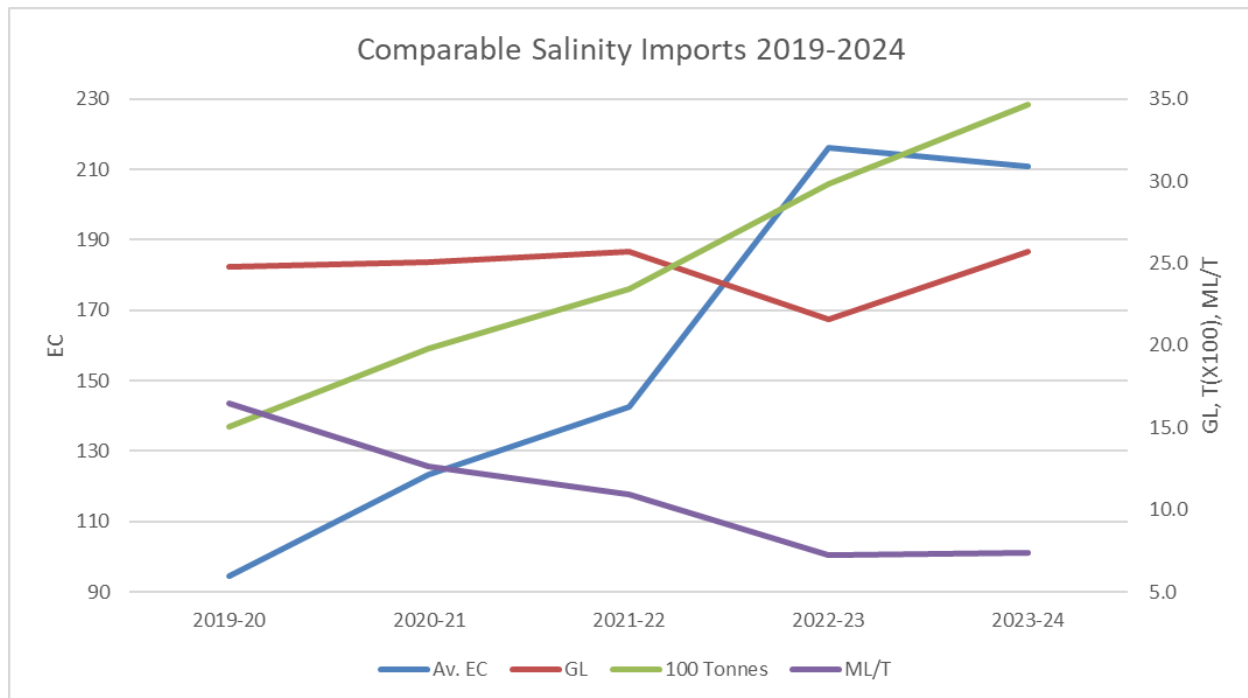
This chart shows the effect of EC on annual salt imports.

(c) There are no new targets identified, the salt imports are controlled purely by the salt content of the river and quantity of water extracted. The annual EC average has been calculated by daily salt imported in tonnes /daily water pumped in GL/0.64; this gives a true average EC of 'imported' water. This is an identified benchmark although we have no control over this.

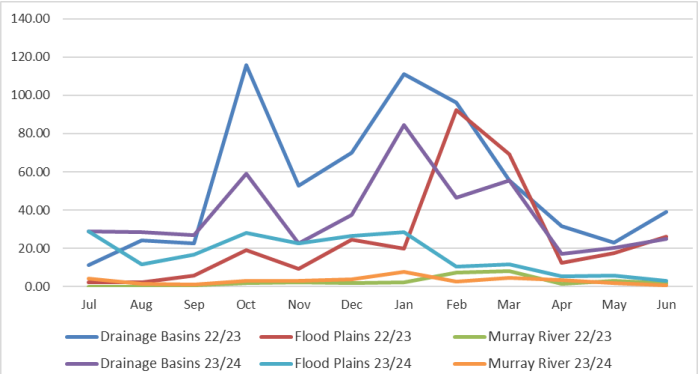
Drainage water (ML) - Comparable data for last 2 years						
	Drainage Basins 22/23	Flood Plains 22/23	Murray River 22/23	Drainage Basins 23/24	Flood Plains 23/24	Murray River 23/24
Jul	11.35	2.37	0.00	28.98	28.65	4.03
Aug	24.04	2.21	0.00	28.26	11.42	1.38
Sep	22.71	5.60	0.60	26.82	16.60	0.93
Oct	115.84	19.04	1.79	58.99	27.95	2.79
Nov	52.86	9.22	2.07	22.63	22.52	2.80
Dec	69.80	24.38	1.97	37.50	26.37	3.89
Jan	111.11	19.96	1.98	84.30	28.44	7.66
Feb	96.31	92.20	7.26	46.57	10.25	2.68
Mar	55.42	69.22	8.19	55.36	11.49	4.50
Apr	31.39	12.42	1.46	16.89	5.29	3.18
May	23.02	17.56	2.96	20.22	5.52	1.65
Jun	38.95	26.26	1.66	24.77	3.04	0.42

c) The majority of the drainage water trend follows the irrigation demand and to a lesser degree rainfall events. 2022/23 irrigation supply was 104.51% of the 5-year average; Rainfall was 216.9mm, below the 50-year average of 287.6mm considerably less than last year. There was a decrease in drainage water, even though irrigation supply was up, possibly in line with the decrease in rainfall. Salinity in both supplied water and drainage water has been higher than normal. Since 2019, WMI have used pulsed hydrogen peroxide dosing, currently at 4 hours a day at 5ppm at all our extraction sites, this is increased up to 24/7 depending on river water quality and demand; This is to control bryozoan growths in the pipeline, aimed at improved water quality at customer outlets; Customers have generally noticed their on-farm filters have been running for longer between backflushes, this has reduced the quantity of backflush water returned to the surface drain system; although when river water quality is bad, peroxide dosing cannot dissolve organic matter in the pipeline.

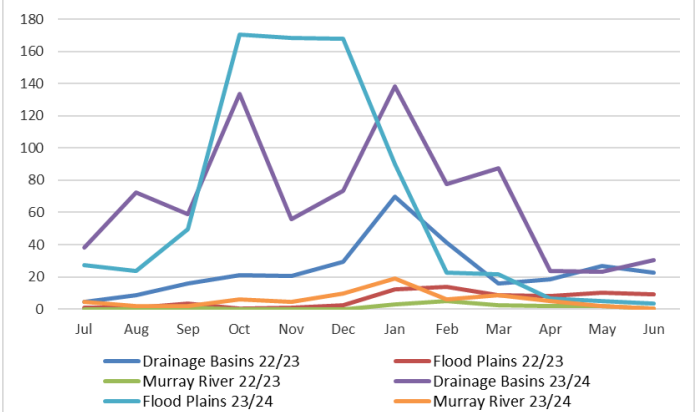
Salt Exports (T) - Comparable data for last 2 years						
	Drainage Basins 22/23	Flood Plains 22/23	Murray River 22/23	Drainage Basins 23/24	Flood Plains 23/24	Murray River 23/24
Jul	13.79	3.73	0.00	38.23	27.35	4.59
Aug	28.62	3.21	0.00	72.22	23.85	1.97
Sep	31.65	8.10	0.79	58.94	49.61	1.68
Oct	146.86	20.42	2.20	133.86	170.65	5.87
Nov	64.71	16.46	2.64	55.67	168.59	4.41
Dec	85.05	26.69	2.62	73.70	167.67	9.72
Jan	127.42	20.57	2.43	138.10	89.81	19.22
Feb	141.41	99.79	9.99	77.56	22.66	5.99
Mar	80.53	149.34	12.37	87.32	21.81	8.65
Apr	39.04	14.37	1.93	23.73	6.47	5.23
May	27.00	15.35	2.90	23.14	5.19	1.72
Jun	61.90	34.67	2.76	30.20	3.50	0.56

d) Salt exported follows a similar pattern to drainage water throughout the year; Long term change from dominant furrow irrigation in 1997 to dominant drip irrigation in 2024 has reduced drainage water from 4848ML in 1998/99 to 684ML in 2023/24; exported salt in 1998/99 was 6,538 tonnes, while 2023/24 was 1,639 tonnes. If salt exports are compared against salt imports, it appears the imported salt is being partially retained on irrigated land; sustained rainfall may control the salinity to some extent, plus the ground water may return to the river/basins/floodplains through unmetered courses.

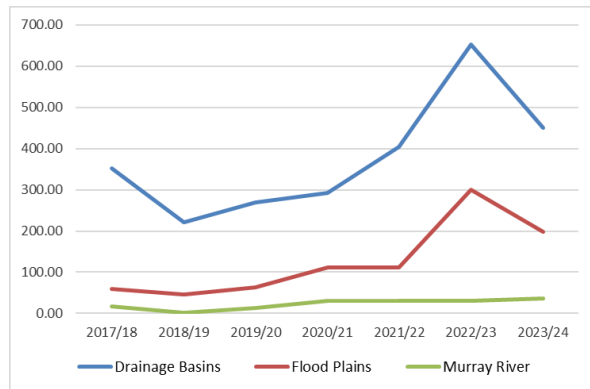
Drainage Water (ML) over 7 years			
	Drainage Basins	Flood Plains	Murray River
2017/18	352.41	58.93	17.57
2018/19	221.99	46.33	1.81
2019/20	268.59	63.23	13.27
2020/21	293.28	111.00	30.56
2021/22	403.48	110.66	31.23
2022/23	652.80	300.44	29.93
2023/24	451.30	197.53	35.91

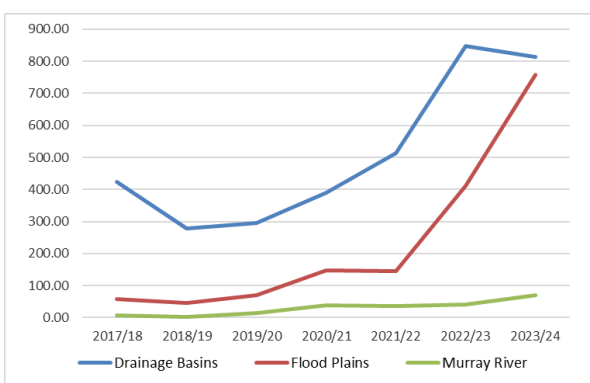
Salt Exports (T) over 7 years			
	Drainage Basins	Flood Plains	Murray River
2017/18	422.96	58.38	7.88
2018/19	277.27	46.96	2.09
2019/20	295.00	70.44	14.42
2020/21	389.58	148.48	38.56
2021/22	512.94	145.64	37.06
2022/23	847.96	412.69	40.61
2023/24	812.68	757.16	69.62

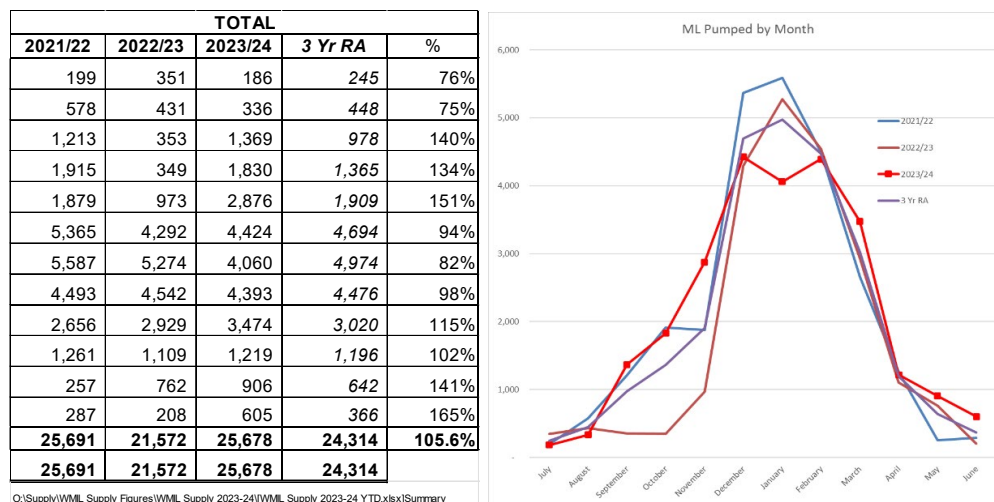
a) Comparable extraction data (ML) for at least 2 previous years (3 years):

2023/24 extraction (ML) was 5.6% above the 3-year average, Rainfall was 217mm, 25% below 50-year average.

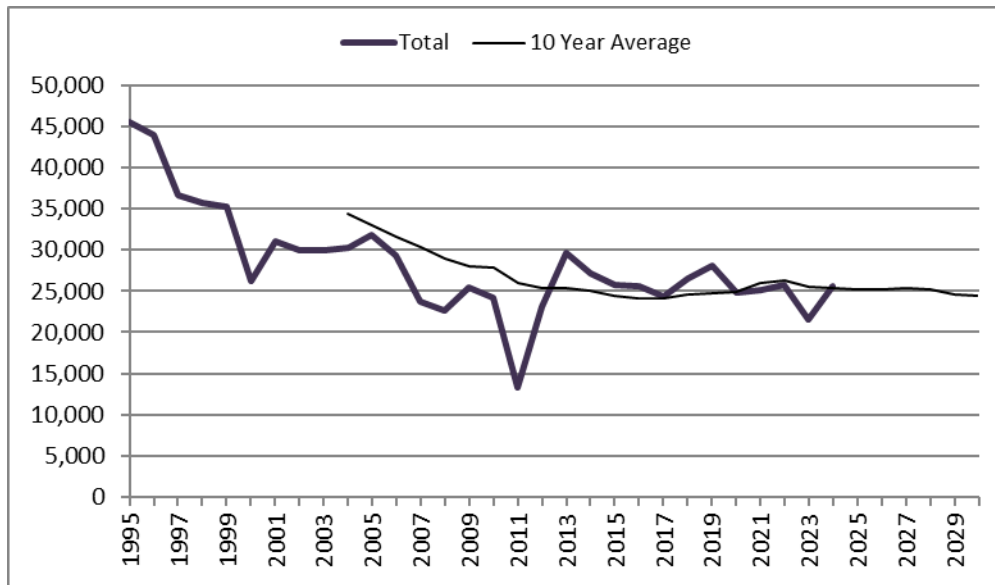
Long-term annual extraction:

c) Long-term extraction shows a marked reduction in water usage; utilisation of irrigation area is presently at 79% (2021), 1997 this was 98%; Irrigable area has increased by 9% from 1997. Water savings have largely been achieved by a change from dominant furrow irrigation in 1997 to dominant drip irrigation in 2021:

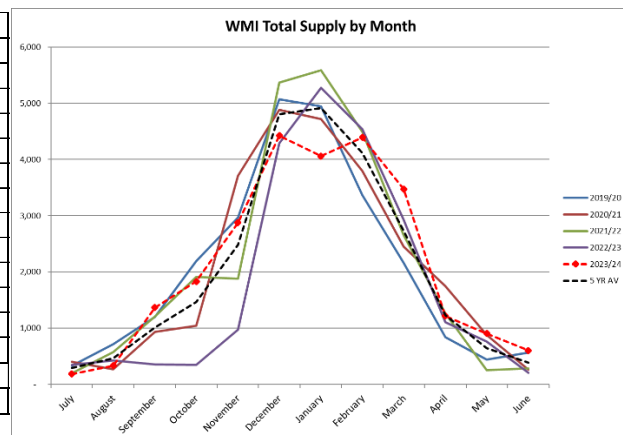
Monthly extraction over the past 5 years:

Month	Total WMI Diversions					5 YR AV
	2019/20	2020/21	2021/22	2022/23	2023/24	
July	335	404	199	351	186	295
August	714	268	578	431	336	465
September	1,204	936	1,213	353	1,369	1,015
October	2,193	1,044	1,915	349	1,830	1,466
November	2,967	3,710	1,879	973	2,876	2,481
December	5,071	4,885	5,365	4,292	4,424	4,808
January	4,945	4,718	5,587	5,274	4,060	4,917
February	3,364	3,794	4,493	4,542	4,393	4,117
March	2,165	2,451	2,656	2,929	3,474	2,735
April	841	1,748	1,261	1,109	1,219	1,235
May	444	879	257	762	906	650
June	572	262	287	208	605	387
Year to Date	24,816	25,099	25,691	21,572	25,678	24,571
Total	24,816	25,099	25,691	21,572	25,678	24,571

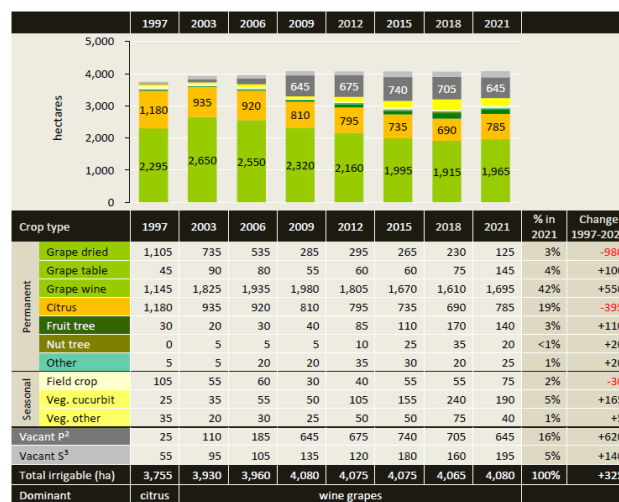
Figure 2: Western Murray Irrigation - crop types from 1997 to 2021

- 2023/24 WMI extracted 25,678ML for water use (see 2.5 – Extraction a), this report), this was used predominantly for horticulture with a small amount of this allocated for General Security (86.9ML) and Domestic and Stock use (560ML).
- WMI crops are planned to be surveyed every three years, next report due at end of 2024:

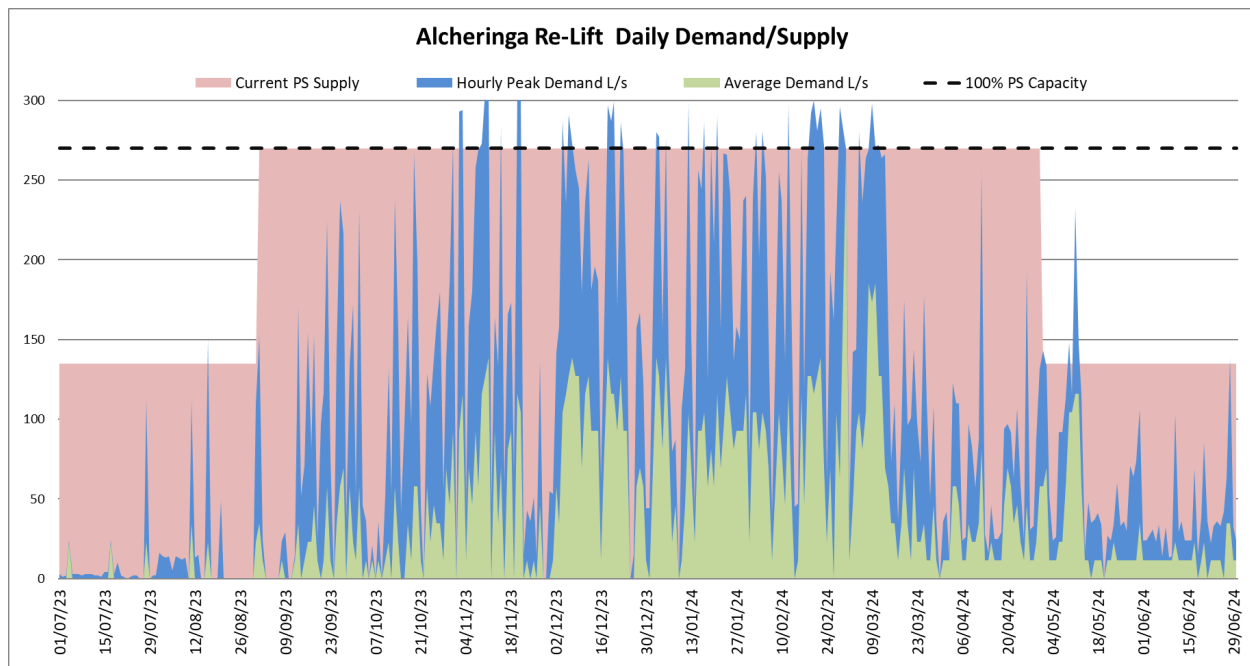
Alcheringa relict pump station emphasises demand at peak season (2023/24). Rain events can be seen mid-Irrigation season where the demand reduces to zero for a few days. When Alcheringa relict pump station is above 270L/s, customer pressure drops below service level; This is a typical irrigation season and is the usual trends we record.

- We are pumping less water annually than 1997, but drip irrigation puts excessive intra-day pressure on our infrastructure (designed around furrow irrigation); days above 40C create very high peaks of demand from drip irrigation systems, targeted pipeline upgrades are necessary to alleviate the intra-day demand, the first upgrade completed in spring 2022 was to alleviate two bottlenecks in our system.

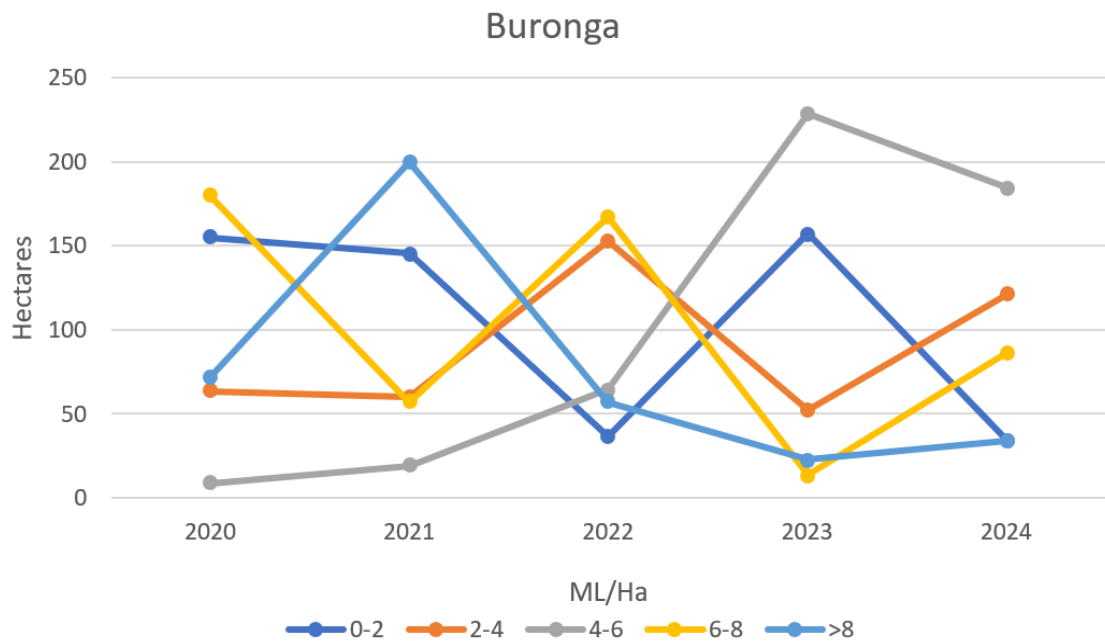
Five intensity ranges total Ha of ML/Ha over a period of 5 years for each irrigation area. The data can easily get distorted e.g. if there is no market for grapes, the growers will cut back on the water to minimal requirements to just keep the vines alive:

Buronga appears erratic, this is due to a lot of replanting, urbanisation, one large irrigator taking supply from another water source and Buronga being a small system. The 4-6ML/Ha range had trended up strongly over 2020/23, while the >8ML/Ha had trended down over the same period, this appears to have stabilised for the 2023/24 year.

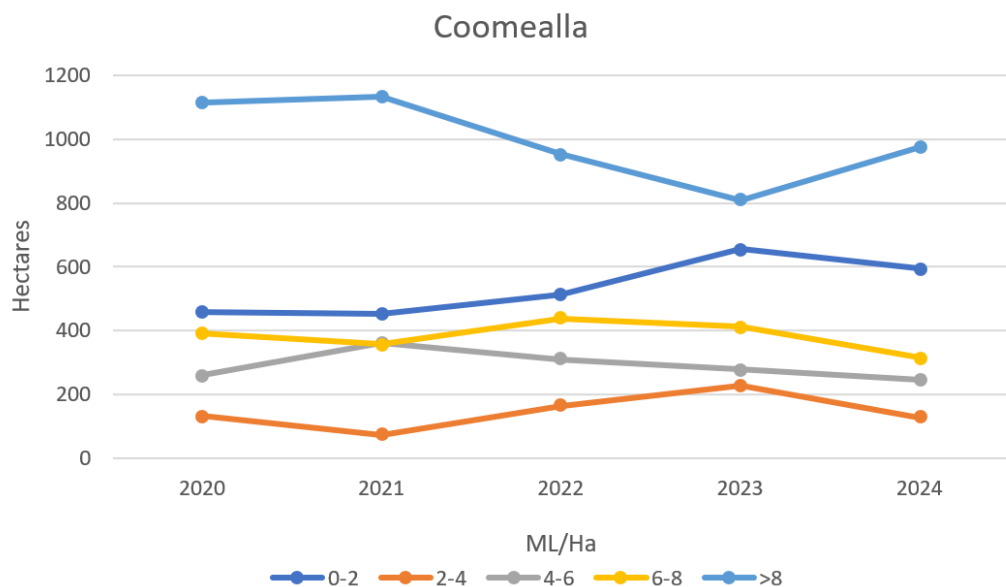
Coomealla has also had a lot of replanting and redevelopment of previously dry blocks for the past 3 years. The >8ML/Ha has trended up this year, while all others have trended down, this is possibly due to the crops planted in the previous years reaching maturity.

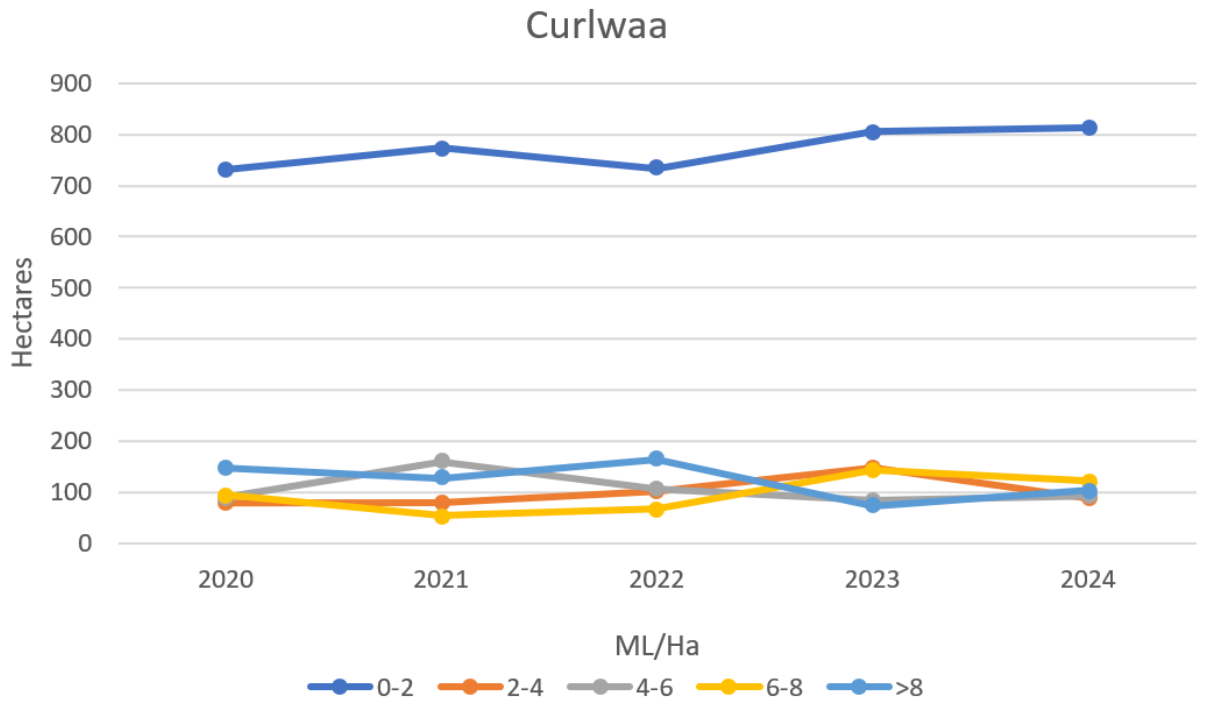
Curlwaa continues a trend of significant land out of production. This trend has continued into 2023-24 with a slight increase of unirrigated land.

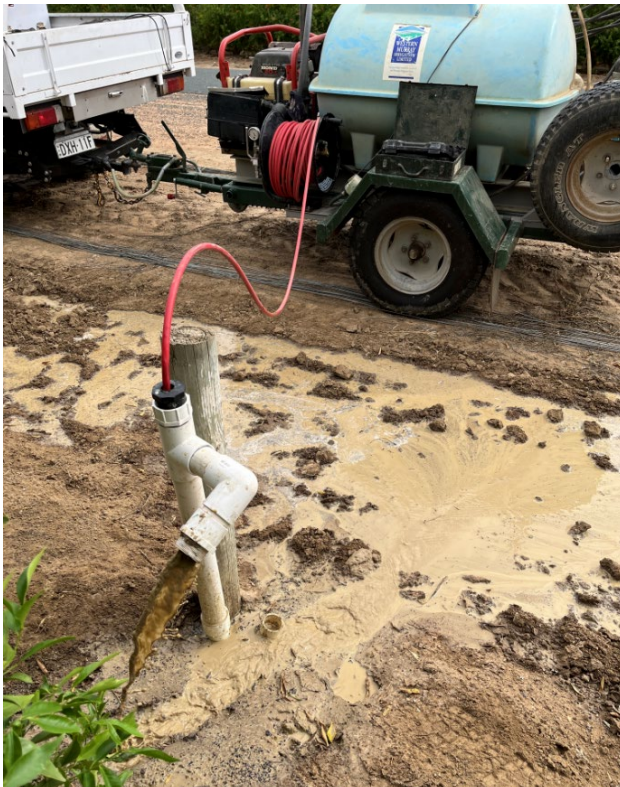
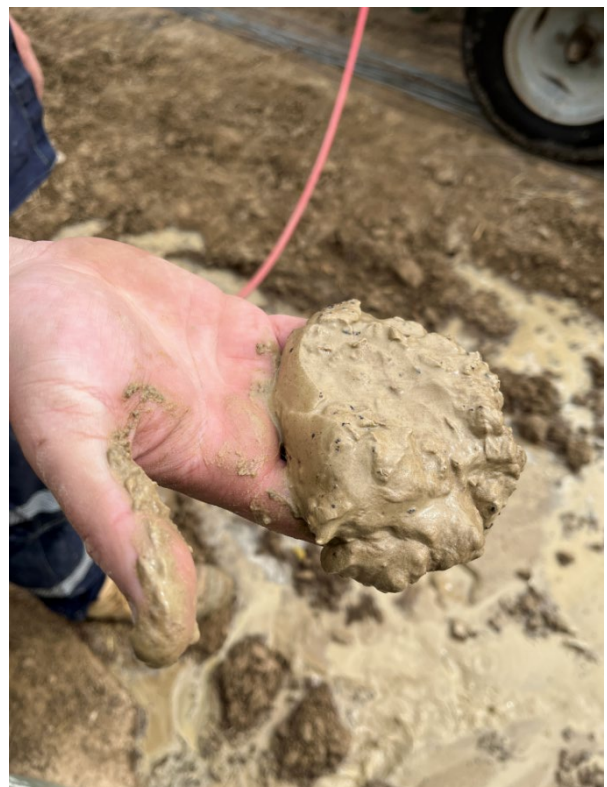
Example of piezometer desilting in progress. This piezometer was previously 'dry', it is now 2M deeper. Will be checked for reading in 2 weeks.

- 100% of WMI controlled Piezometers accounted for. – *Complete; some are completely gone (destroyed), some need some work to bring them back into service.*
- GPS location re-established for GDA1994. *A two-stage verification has been carried out, desktop utilising GIS and a physical GPS read using a hand-held GPS, a lot of sites are walk-in only.*
- AHD, screen depth and overall depth measured and confirmed at each piezometer. – *There is no way of physically confirming screen depth; overall depth has been measured. Missing AHDs have not been established 2023/24.*
- Assess dry/destroyed piezometers for rehabilitation. A lot of work has been carried out this year to rework piezometers that were under water during the flood. These have commonly filled with silt; removal is time consuming.

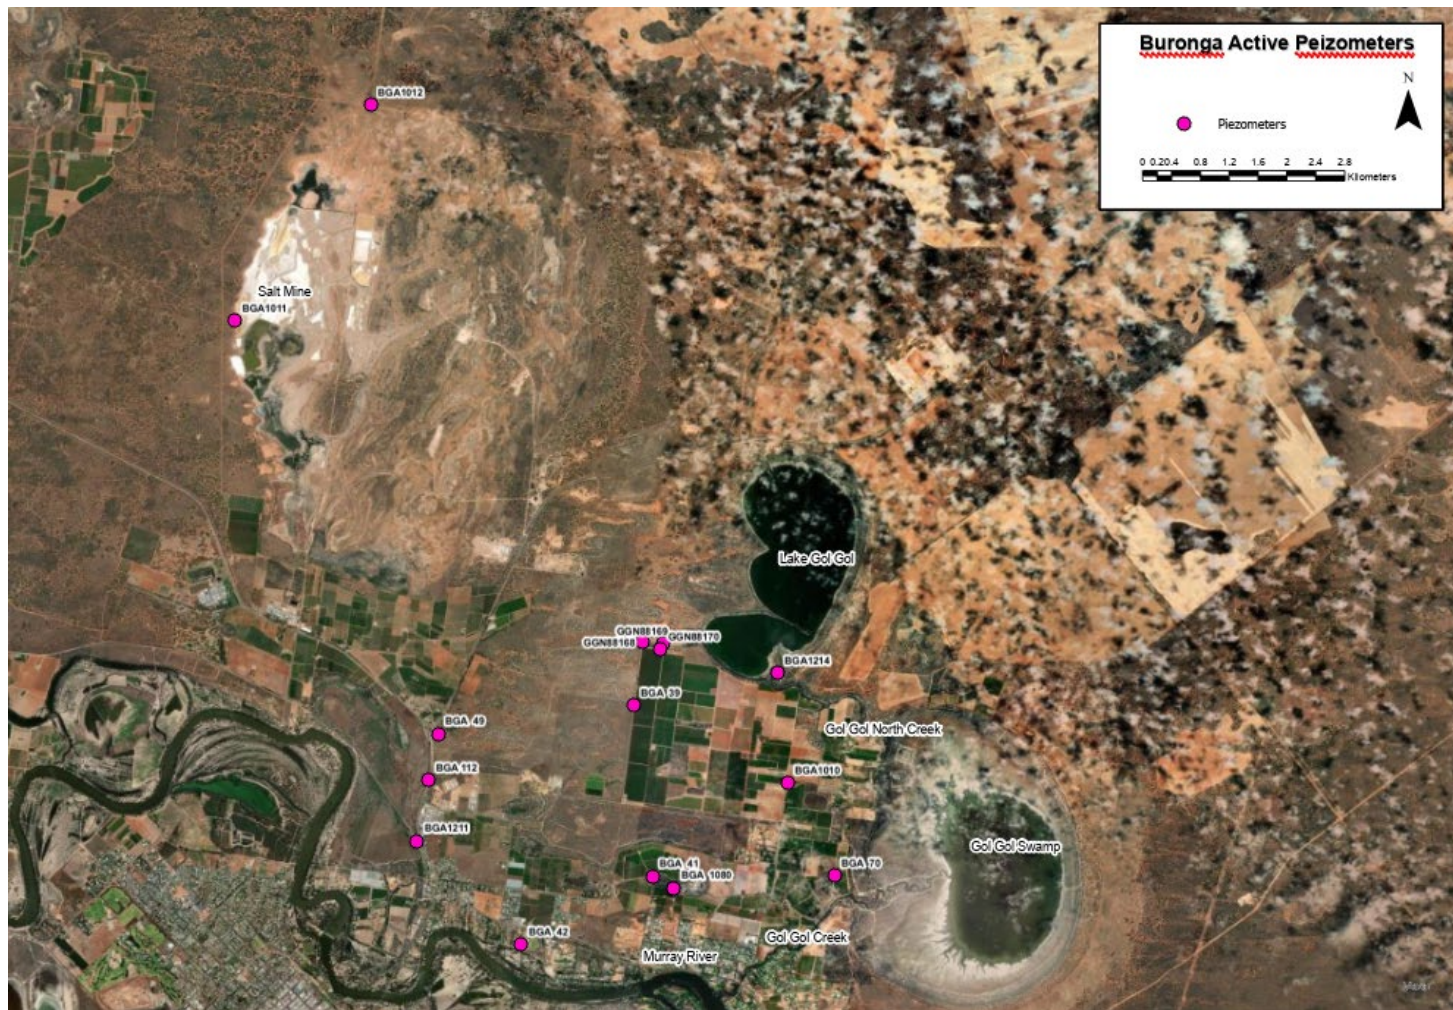
Location of Active Buronga Piezometers:

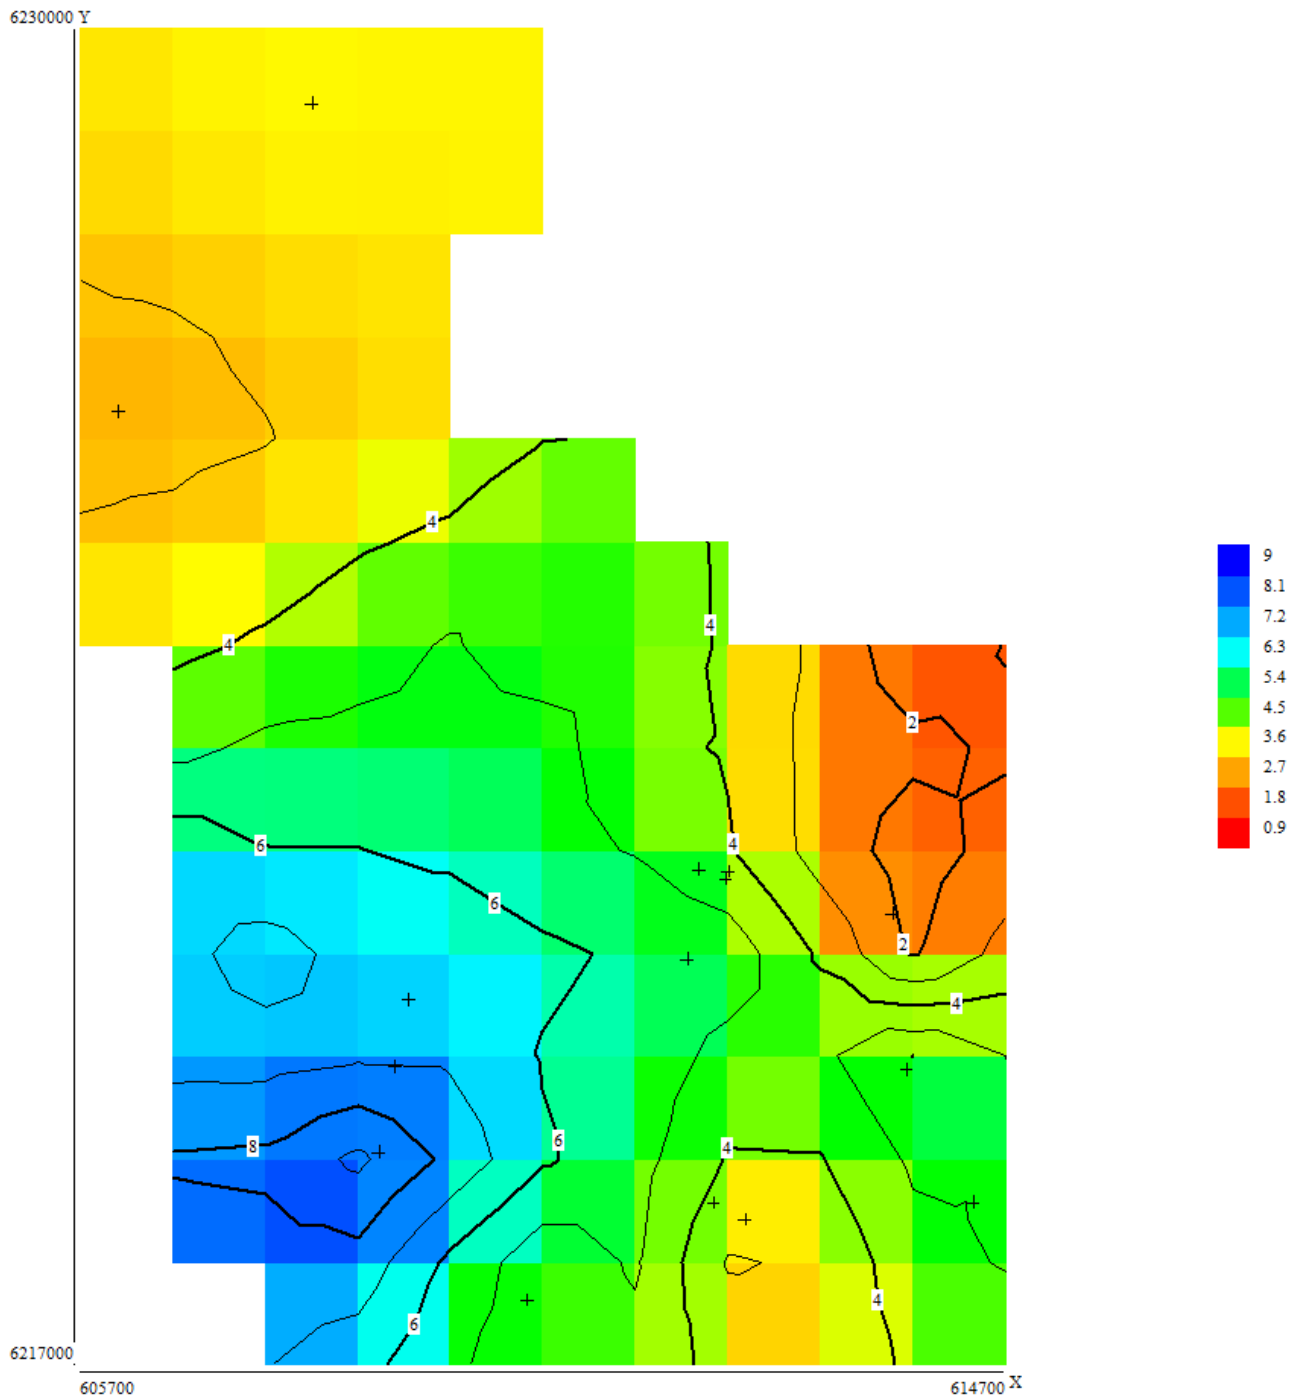
Map of groundwater depth below natural surface @ 2M contour intervals and including first 1M. Dry/destroyed piezometers are not used for constructing contour lines.

Buronga groundwater heights below natural surface (M)

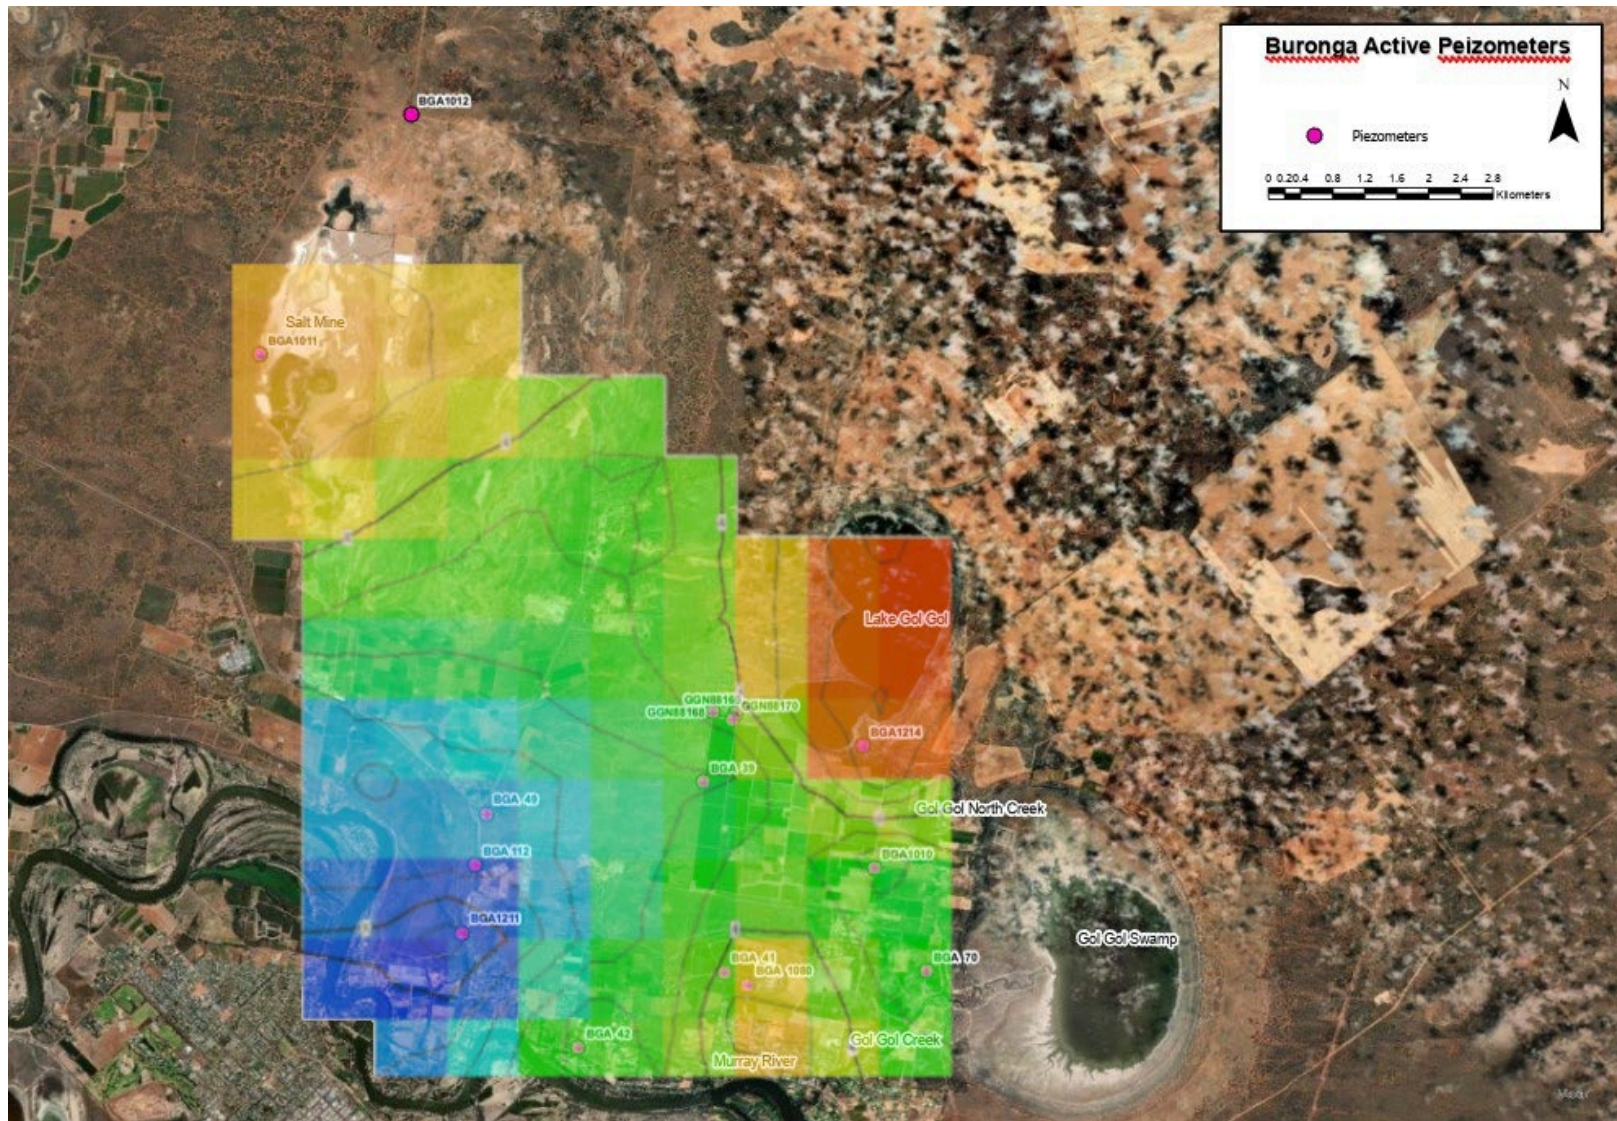
Buronga groundwater heights below natural surface (M), combined image:

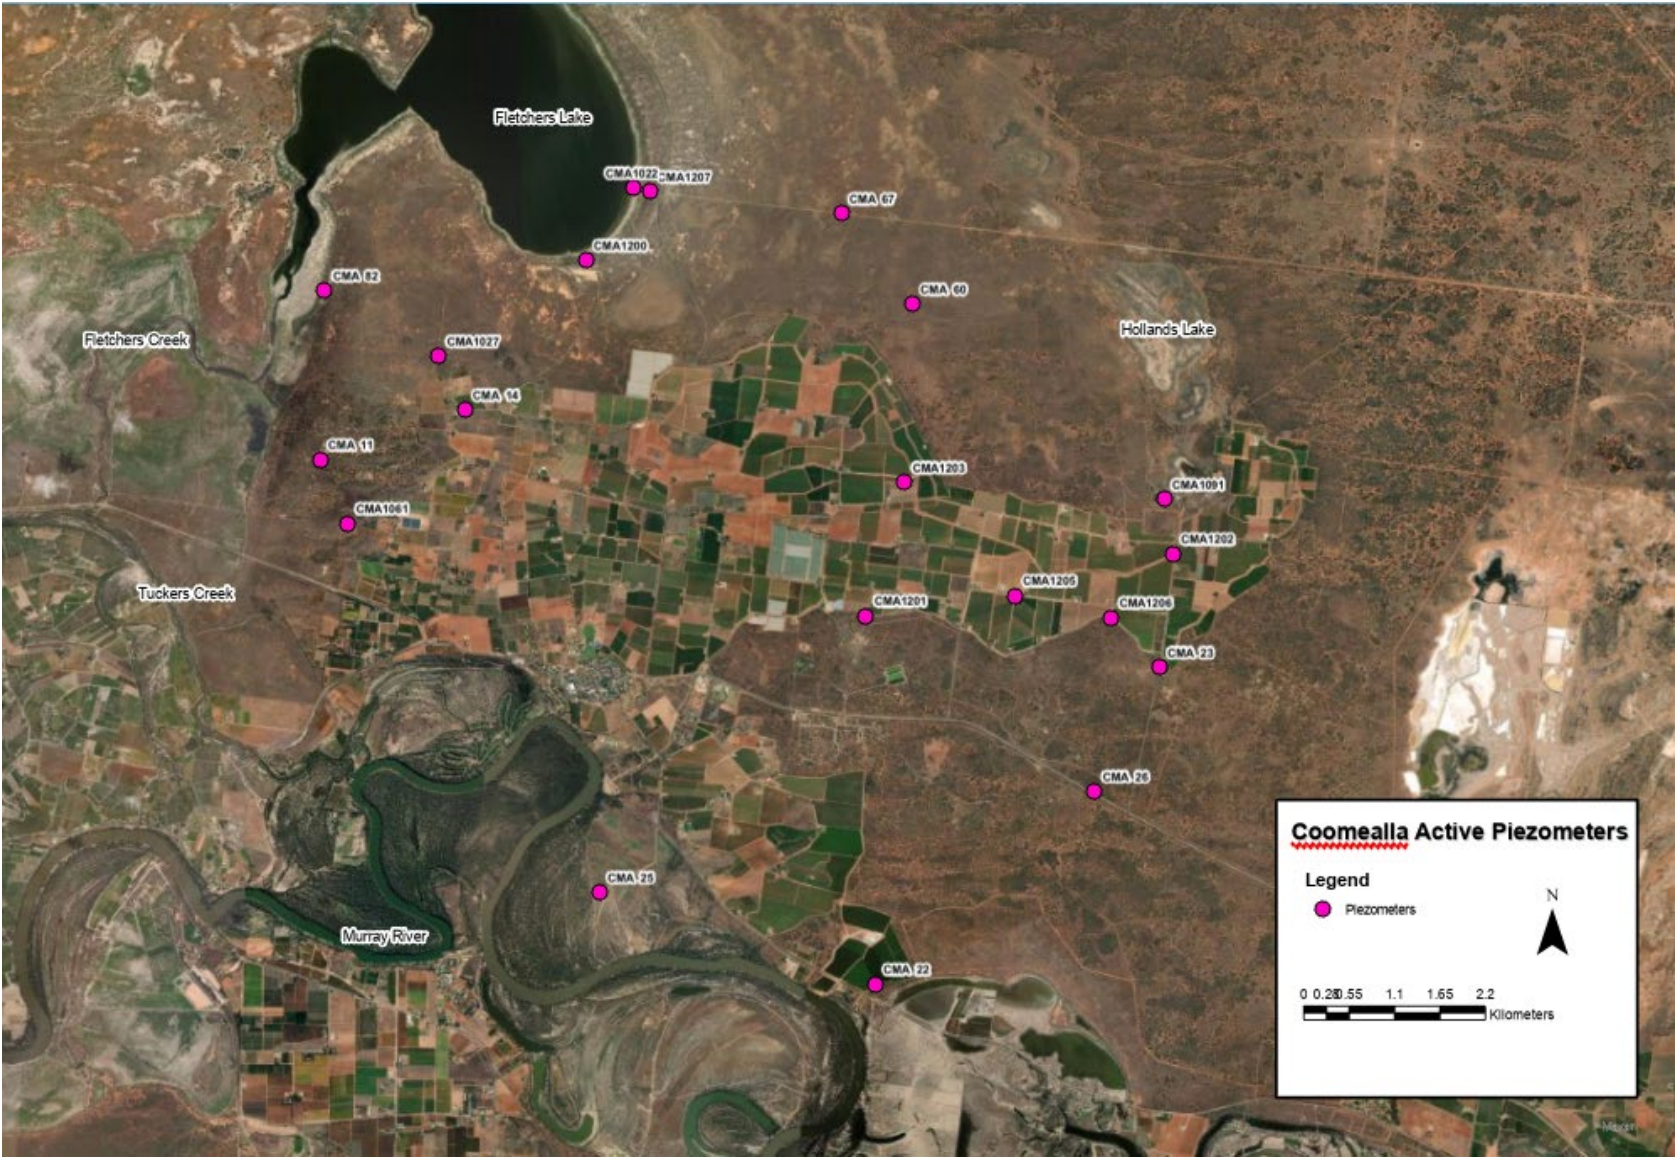
Location of Active Coomealla piezometers:

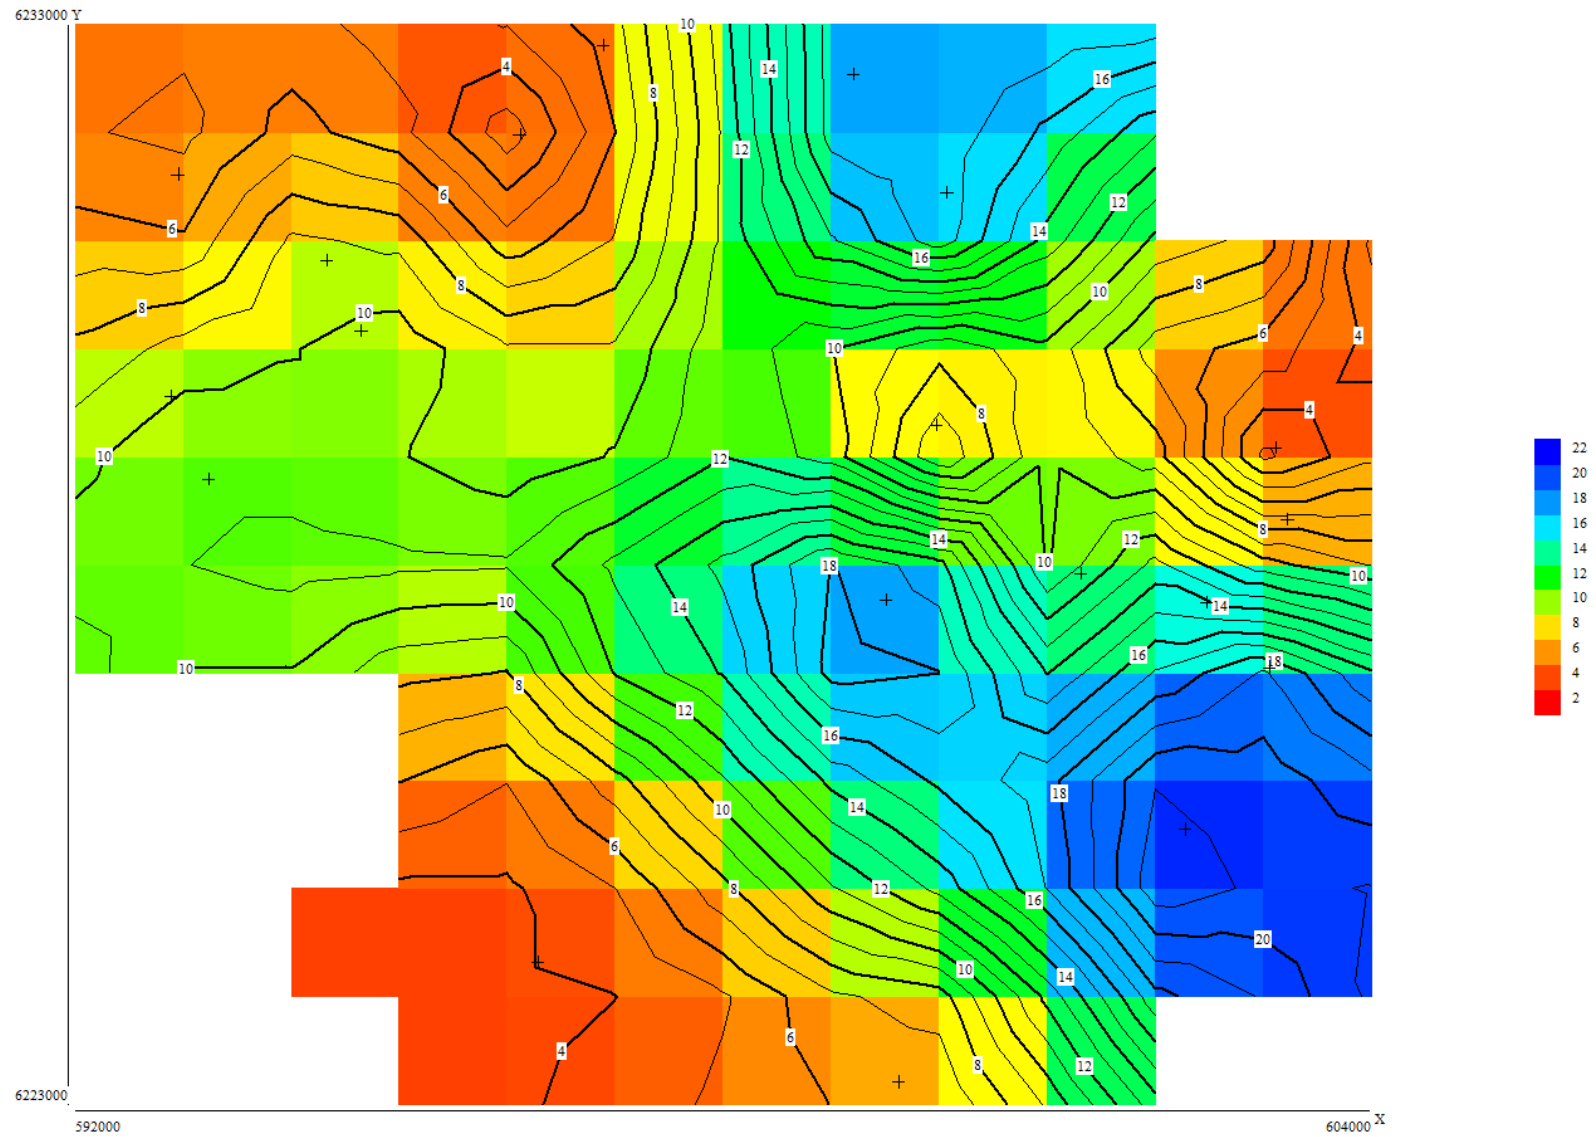
Coomealla groundwater height below natural surface (M):

Groundwater contour maps have been provided at condition 1; Groundwater levels are expected to be decreasing after the flooding event. All piezometers are read in August/September of each year.

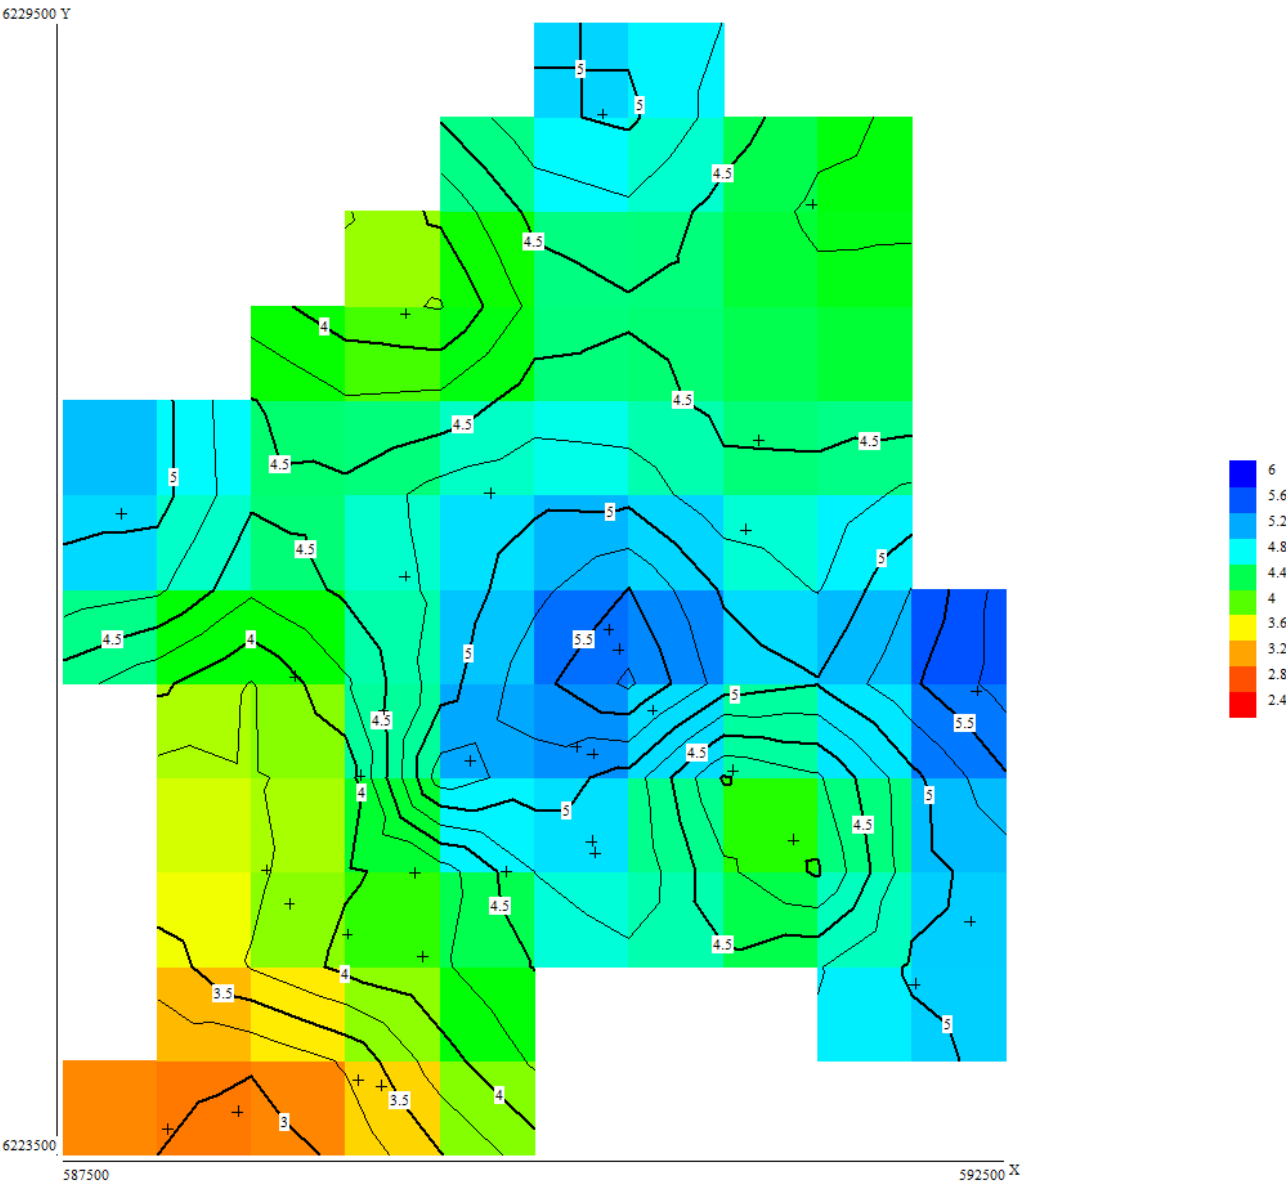
Curlwaa groundwater height below natural surface (M):
