ANNUAL COMPLIANCE REPORT

(Combined Approval 60CA581273)

2023/24

LICENCE COMPLIANCE REPORT 2023/24

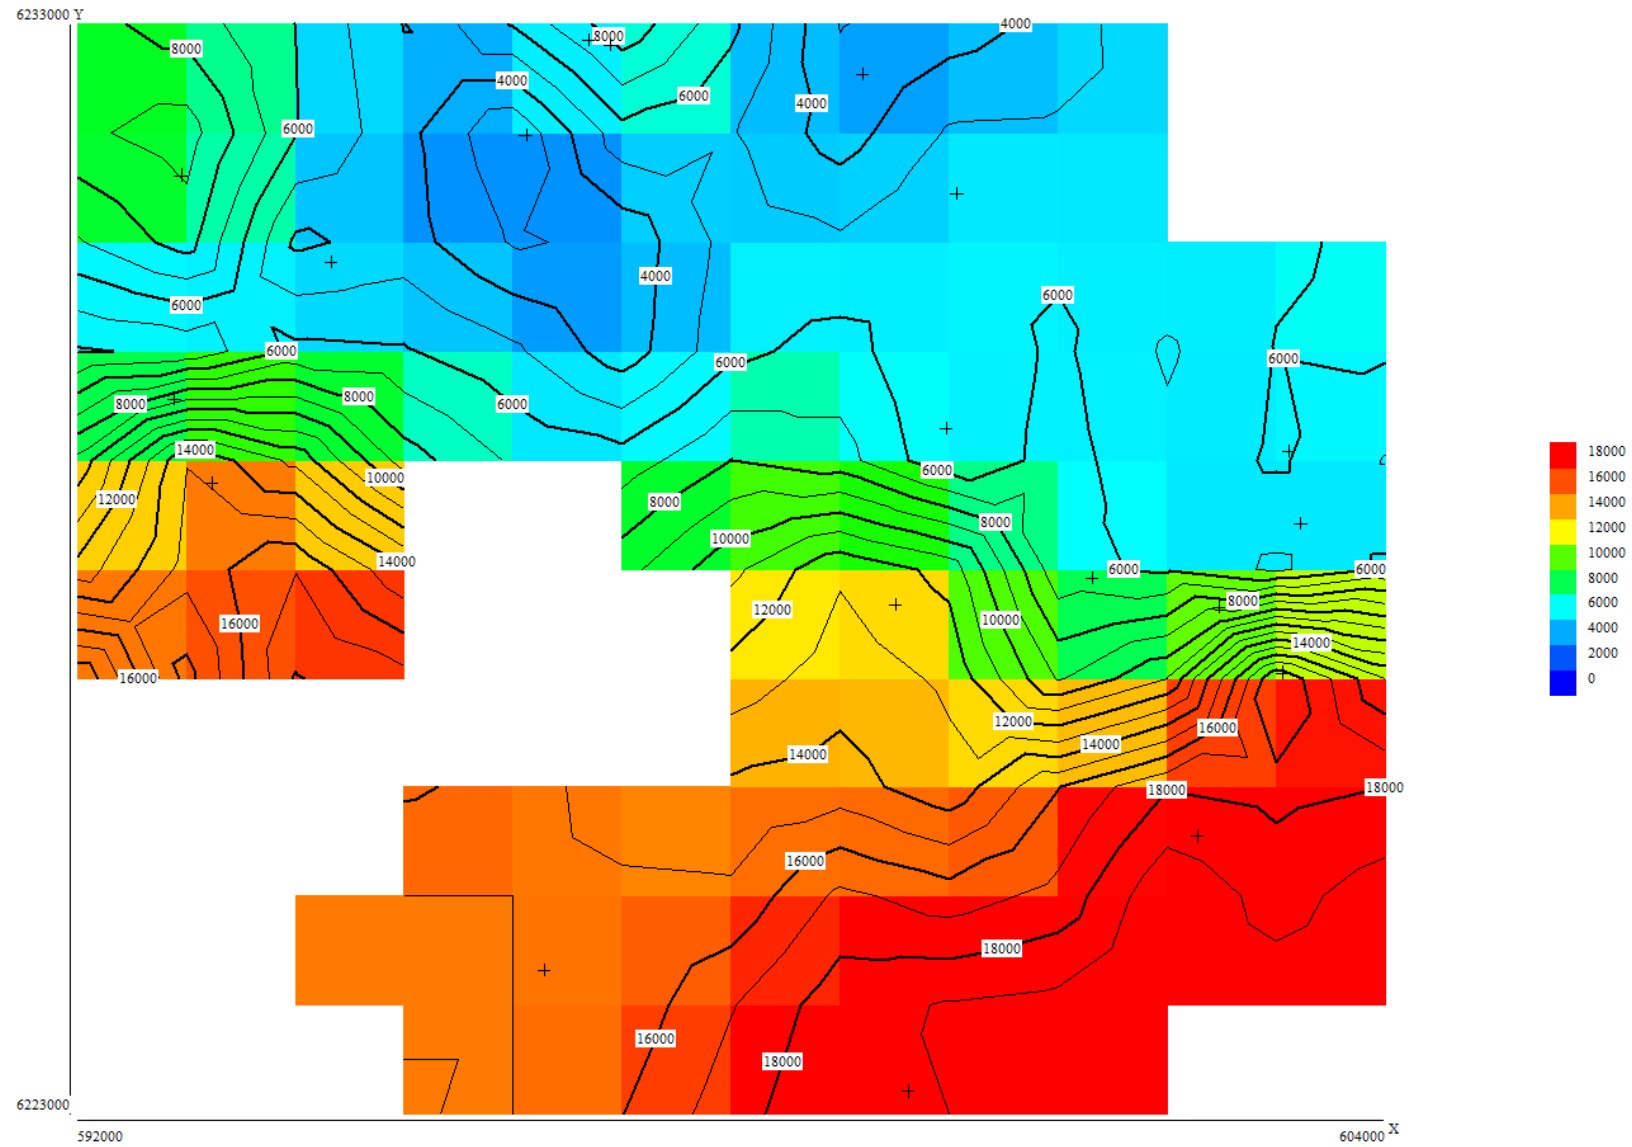
Coomoalla Salinity Contours:
