LICENCE COMPLIANCE REPORT 2022/23

Western Murray Irrigation Limited

2022/23 Annual Compliance report

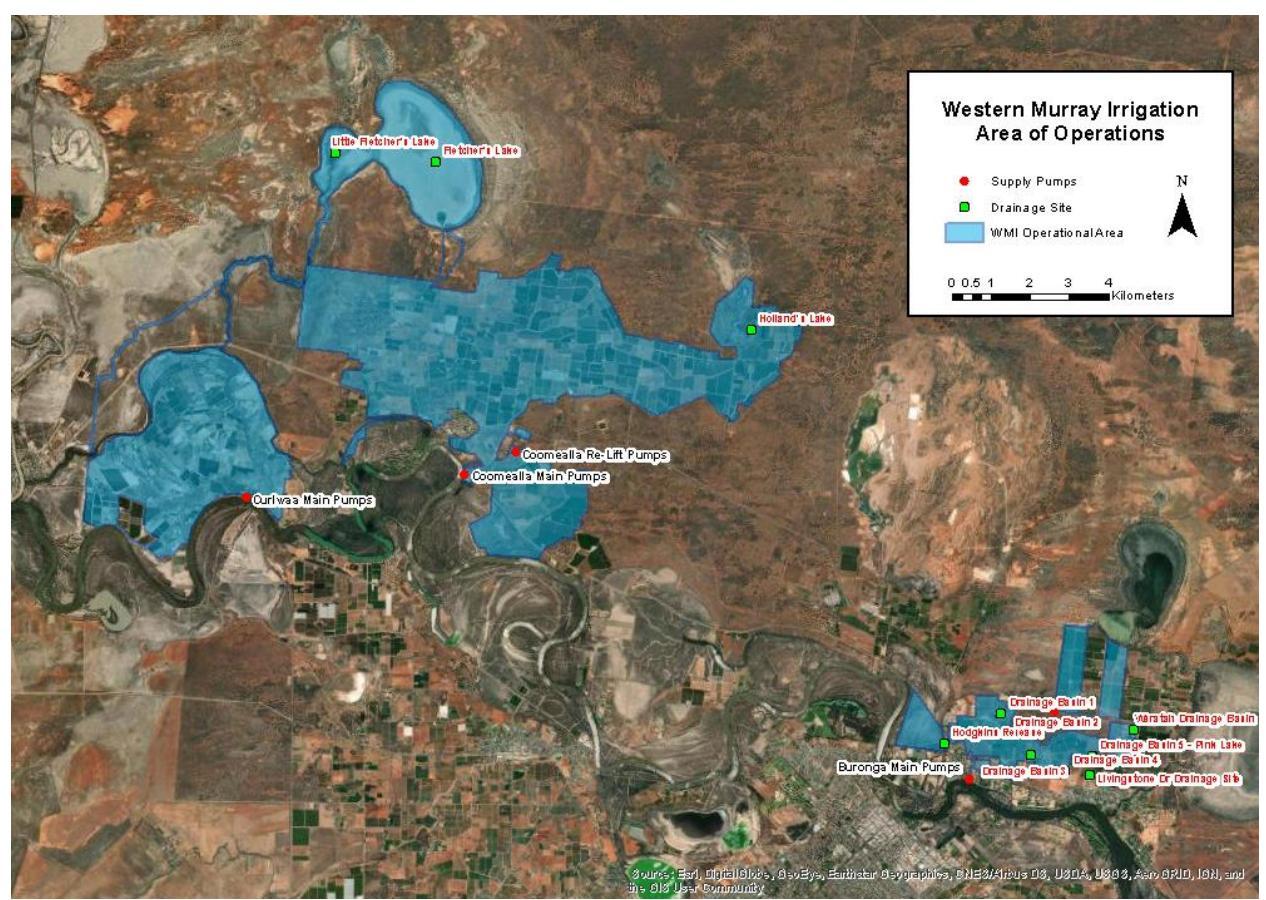
WMI Operational Area

Area of Operations, existing on 30 June 2023, showing, to the Minister's satisfaction, the boundary of all included land and including any amendments made by the inclusion and exclusion of lands in accordance with sections 131 and 135 of the *WMA 2000*, and showing the boundary of any other land water is suppled to that are not included in the Area of Operations. Zero changes to area of operations in financial year 2022/23; Buronga will show significant losses to operational area in the following 1-3 years as urbanisation takes over irrigable land.

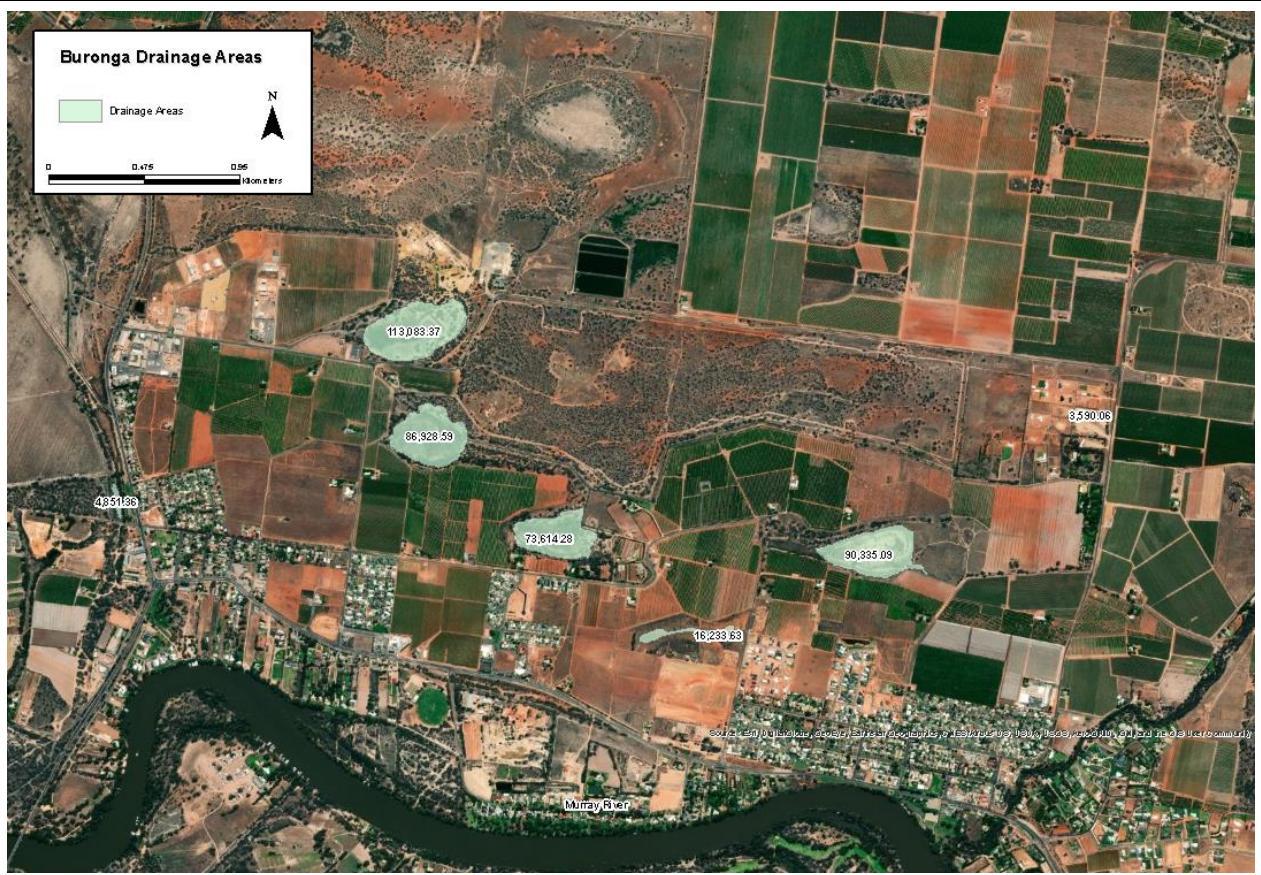
Buronga - Extent of area (square metres) that are temporarily inundated to store drainage and storm water (evaporation basins).

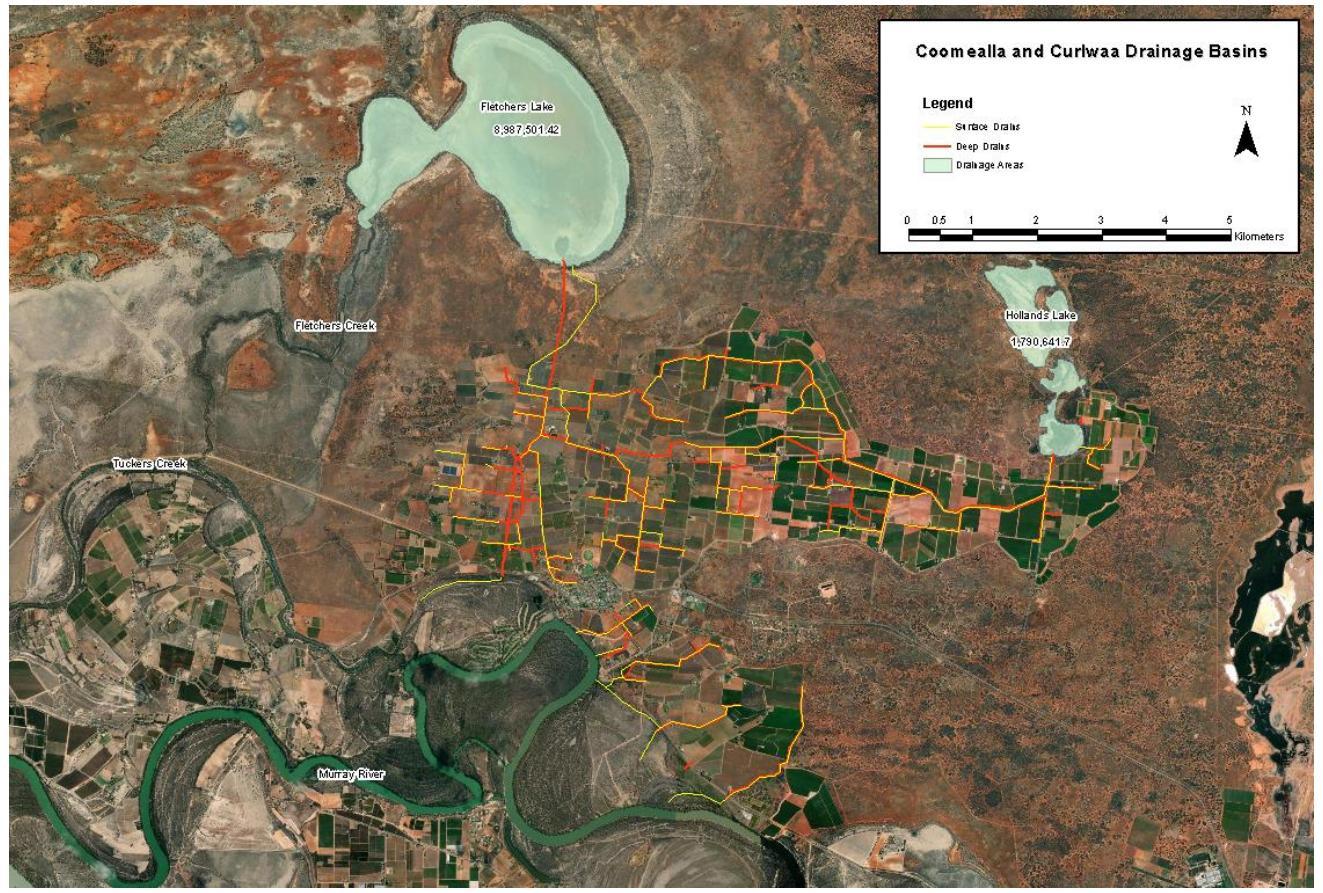
Coomealla and Curlwaa - Extent of area (square metres) that are temporarily inundated to store drainage and storm water (evaporation basins).

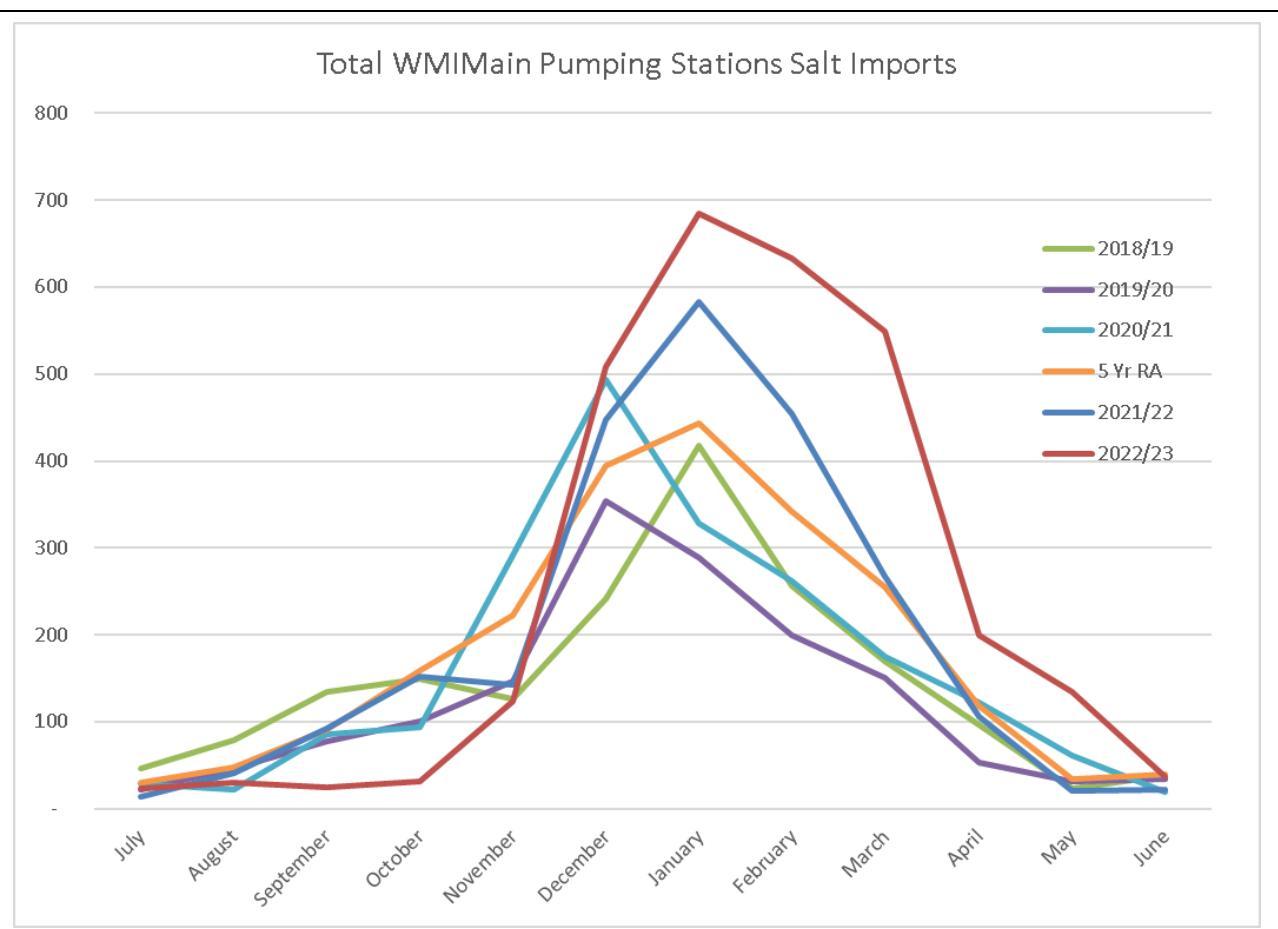
The chart shows seasonal water usage affecting salt imports for each month; Note the increase in 22-23 during the Nov-Mar flood event. For annual trends, see para 2.5 Salinity (b).

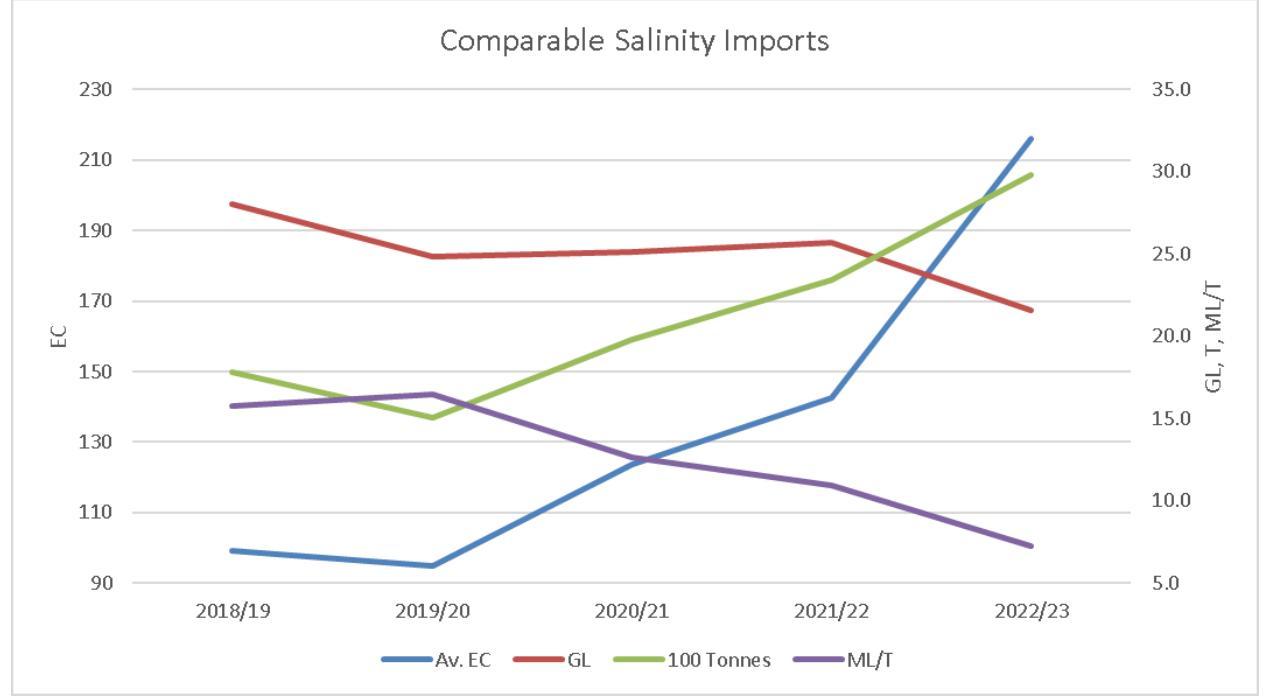
This chart shows the effect of EC on annual salt imports.

(c There are no new targets identified, the salt imports are controlled purely by the salt content of the river and quantity of water extracted. The annual EC average has been calculated by daily salt imported in tonnes /daily water pumped in GL/0.64; this gives a true average EC of 'imported' water. This is an identified benchmark although we have no control over this.

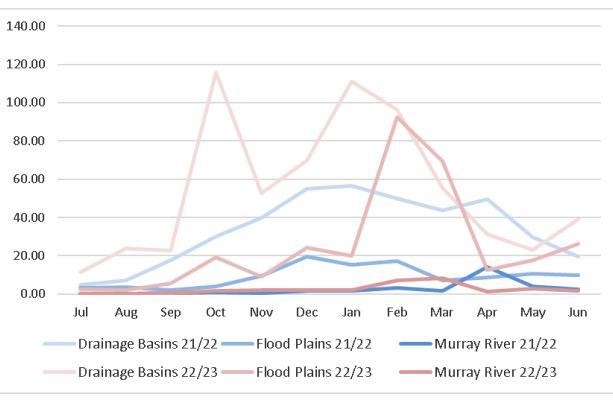
Drai	Drainage water (ML) - Comparable data for last 2 years													
	Drainage Basins 21/22	Flood Plains 21/22	Murray River 21/22	Drainage Basins 22/23	Flood Plains 22/23	Murray River 22/23								
Jul	4.77	3.33	0.00	11.35	2.37	0.00								
Aug	6.98	3.55	0.24	24.04	2.21	0.00								
Sep	17.82	2.07	0.37	22.71	5.60	0.60								
Oct	30.03	3.83	0.83	115.84	19.04	1.79								
Nov	39.65	9.36	0.37	52.86	9.22	2.07								
Dec	55.09	19.65	1.57	69.80	24.38	1.97								
Jan	56.46	15.23	1.83	111.11	19.96	1.98								
Feb	49.85	17.14	3.38	96.31	92.20	7.26								
Mar	43.91	7.17	1.79	55.42	69.22	8.19								
Apr	49.58	8.83	14.21	31.39	12.42	1.46								
May	29.85	10.64	4.10	23.02	17.56	2.96								
Jun	19.47	9.84	2.52	38.95	26.26	1.66

c) The majority of the drainage water trend follows the irrigation demand and to a lesser degree rainfall events. 2022/23 irrigation supply was 98.65% of the 5-year average; Rainfall was 358.0mm, above the 50-year average of 284.6mm considerably more than the last 4 years; there was an increase in drainage water, possibly in line with the increase in rainfall. September 2019 WMI introduced pulsed hydrogen peroxide dosing, currently at 4 hours a day at 5ppm at all our extraction sites, this is increased up to 24/7 depending on river water quality and demand; This is to control bryozoan growths in the pipeline, aimed at improved water quality at customer outlets; Customers have generally noticed their onfarm filters have been running for longer between backflushes, this has reduced the quantity of backflush water returned to the surface drain system; although when river water quality is bad, peroxide dosing cannot dissolve organic matter in the pipeline.

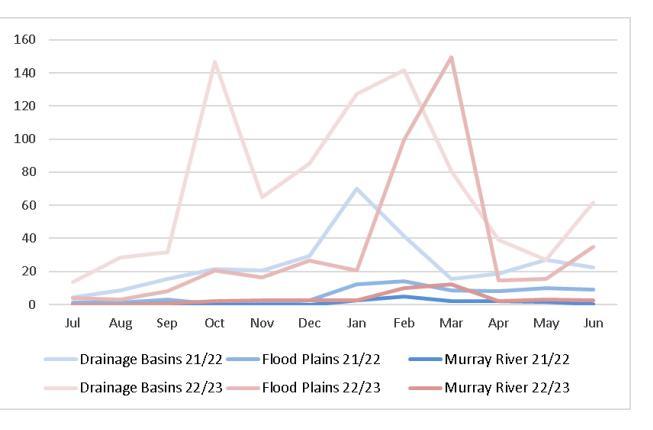
Salt Exports (T) - Comparable data for last 2 years														
	Drainage Basins 21/22	Flood Plains 21/22	Murray River 21/22	Drainage Basins 22/23	Flood Plains 22/23	Murray River 22/23									
Jul	6.70	4.47	0.00	13.79	3.73	0.00									
Aug	10.27	4.74	0.29	28.62	3.21	0.00									
Sep	27.77	2.78	0.47	31.65	8.10	0.79									
Oct	41.96	5.09	0.83	146.86	20.42	2.20									
Nov	55.50	12.00	0.36	64.71	16.46	2.64									
Dec	66.82	25.18	1.86	85.05	26.69	2.62									
Jan	60.59	20.05	2.08	127.42	20.57	2.43									
Feb	60.24	23.55	5.16	141.41	99.79	9.99									
Mar	53.53	9.49	2.38	80.53	149.34	12.37									
Apr	62.47	10.27	16.44	39.04	14.37	1.93									
May	38.84	13.58	3.61	27.00	15.35	2.90									
Jun	28.26	14.43	3.59	61.90	34.67	2.76

d) Salt exported follows a similar pattern to drainage water throughout the year; Long term change from dominant furrow irrigation in 1997 to dominant drip irrigation in 2022 has reduced drainage water from 4848ML in 1998/99 to 983ML in 2022/23; exported salt in 1998/99 was 6,538 tonnes, while 2022/23 was 1,301.26 tonnes. If this is compared against salt imports, it appears the imported salt is now being retained on irrigated land; sustained rainfall may control the salinity to some extent.

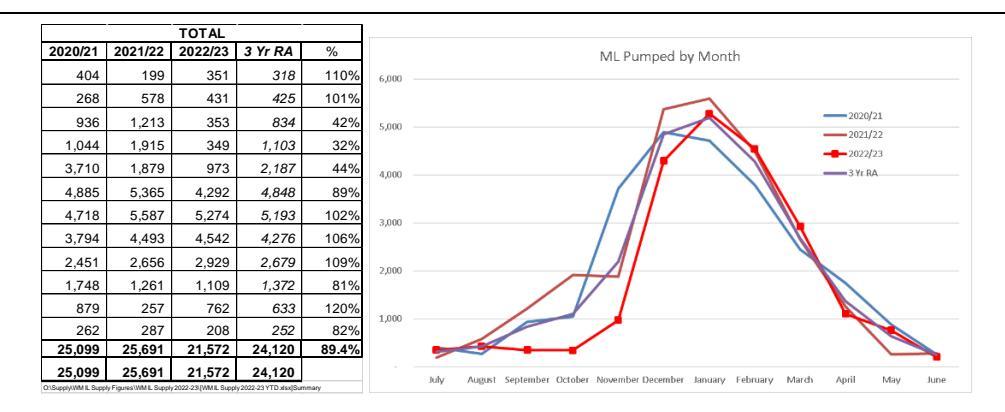
2022/23 extraction (ML) was 11% below the 3-year average, a particularly high rainfall year.

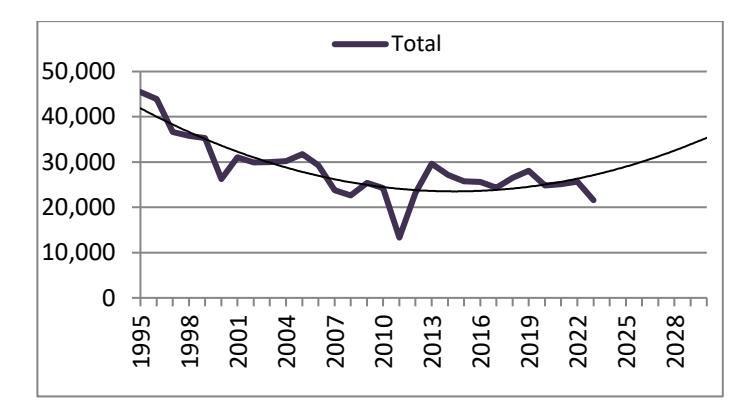
Long-term extraction shows a marked reduction in water usage; utilisation of irrigation area is presently at 79% (2021), 1997 this was 98%; Irrigable area has increased by 9% from 1997. Water savings have largely been achieved by a change from dominant furrow irrigation in 1997 to dominant drip irrigation in 2021:

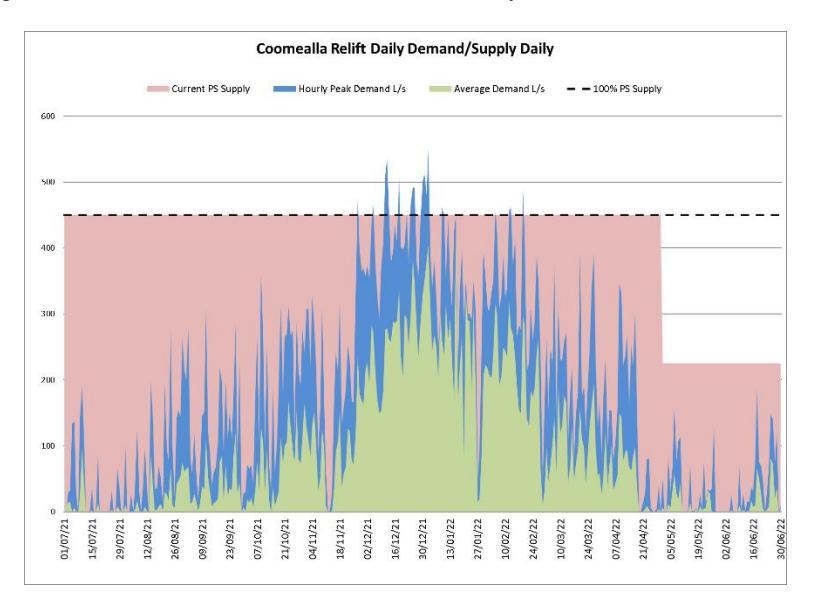
Coomealla relift pump station emphasises demand at peak season (2021/22). Three rain events can be clearly seen effecting demand in November, January, and February. When Coomealla relift pump station is above 450L/s, customer pressure drops below service level; 2022/23 season was a low demand season, and relatively cool summer, those highs were not present for this season.

c) We are pumping less water annually than 1997, but drip irrigation puts excessive intra-day pressure on our infrastructure (designed around furrow irrigation); days above 40C create very high peaks of demand from drip

irrigation systems, targeted pipeline upgrades are necessary to alleviate the intra-day demand, the first upgrade completed in spring 2022 was to alleviate two bottlenecks in our system.

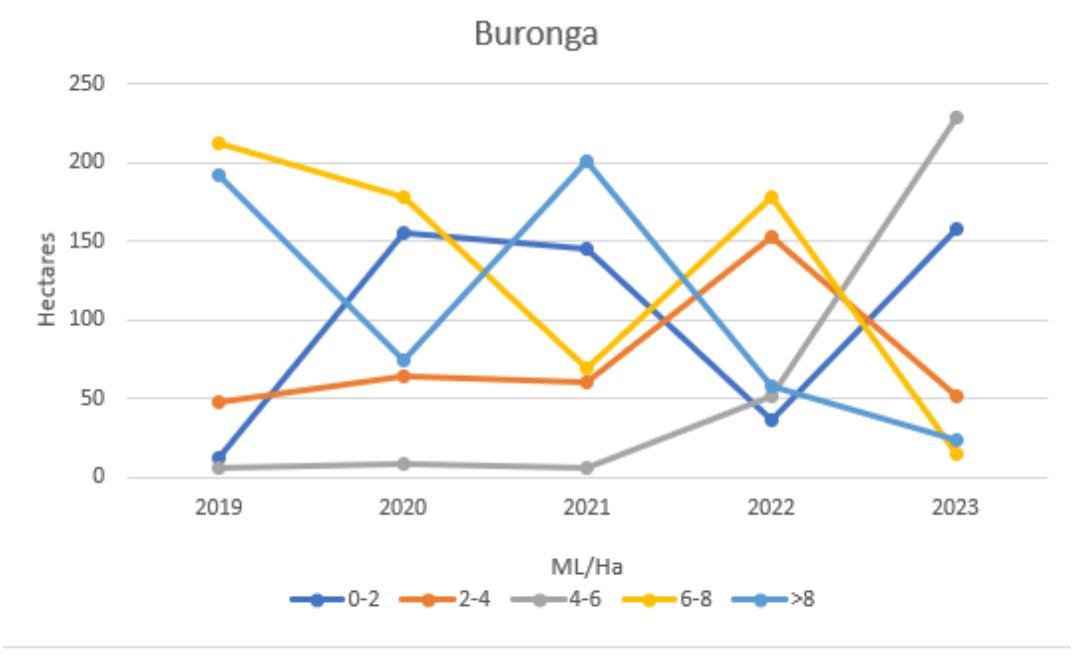
Buronga looks erratic, this is due to a lot of replanting, urbanisation, one large irrigator taking supply from another water source and Buronga being a small system. The 4-6ML/Ha range has trended up strongly over the past 2 seasons, while the >8ML/Ha has trended down.

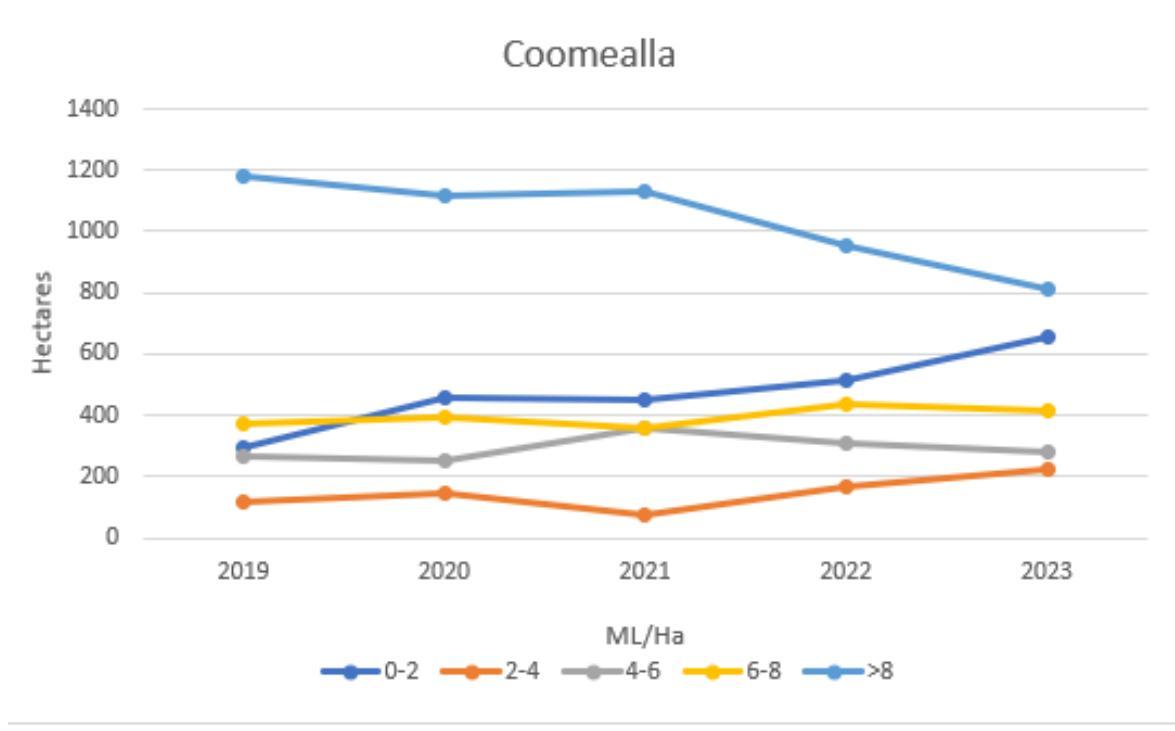
Coomealla has also had a lot of replanting and redevelopment of previously dry blocks. The >8ML/Ha has trended down over the past 2 seasons while the range of 0-2 & 2-4ML/Ha has increased.

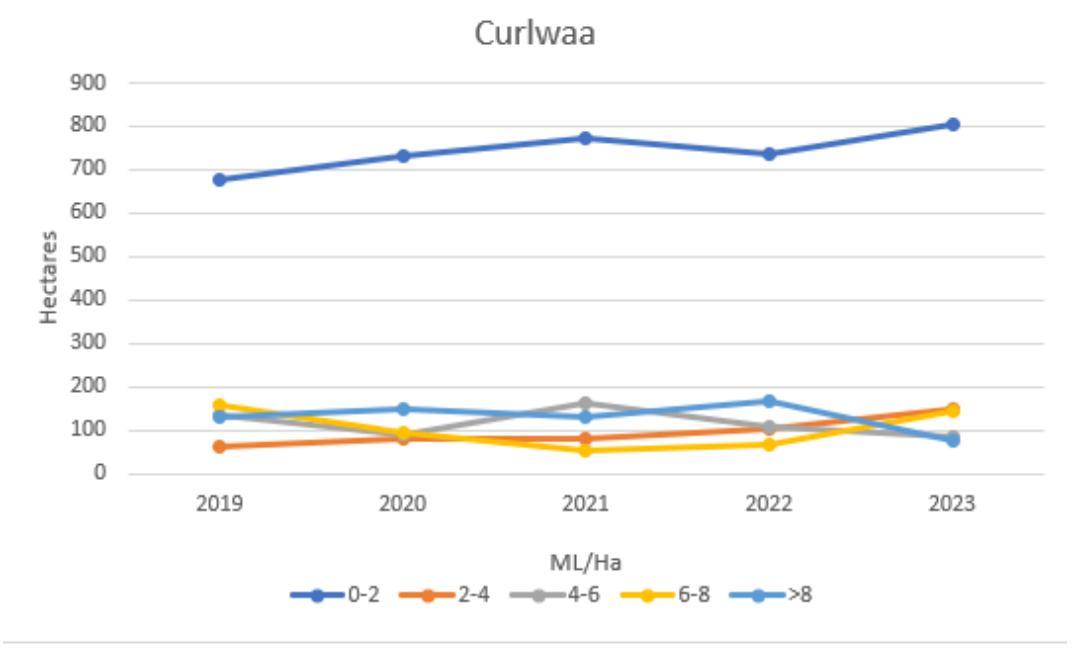
Small increase in large previously dry blocks, but more smaller blocks going dry each year. Curlwaa soil has a high clay content and tends to retain water more than Coomealla and Buronga. This trend has continued into 2022-23

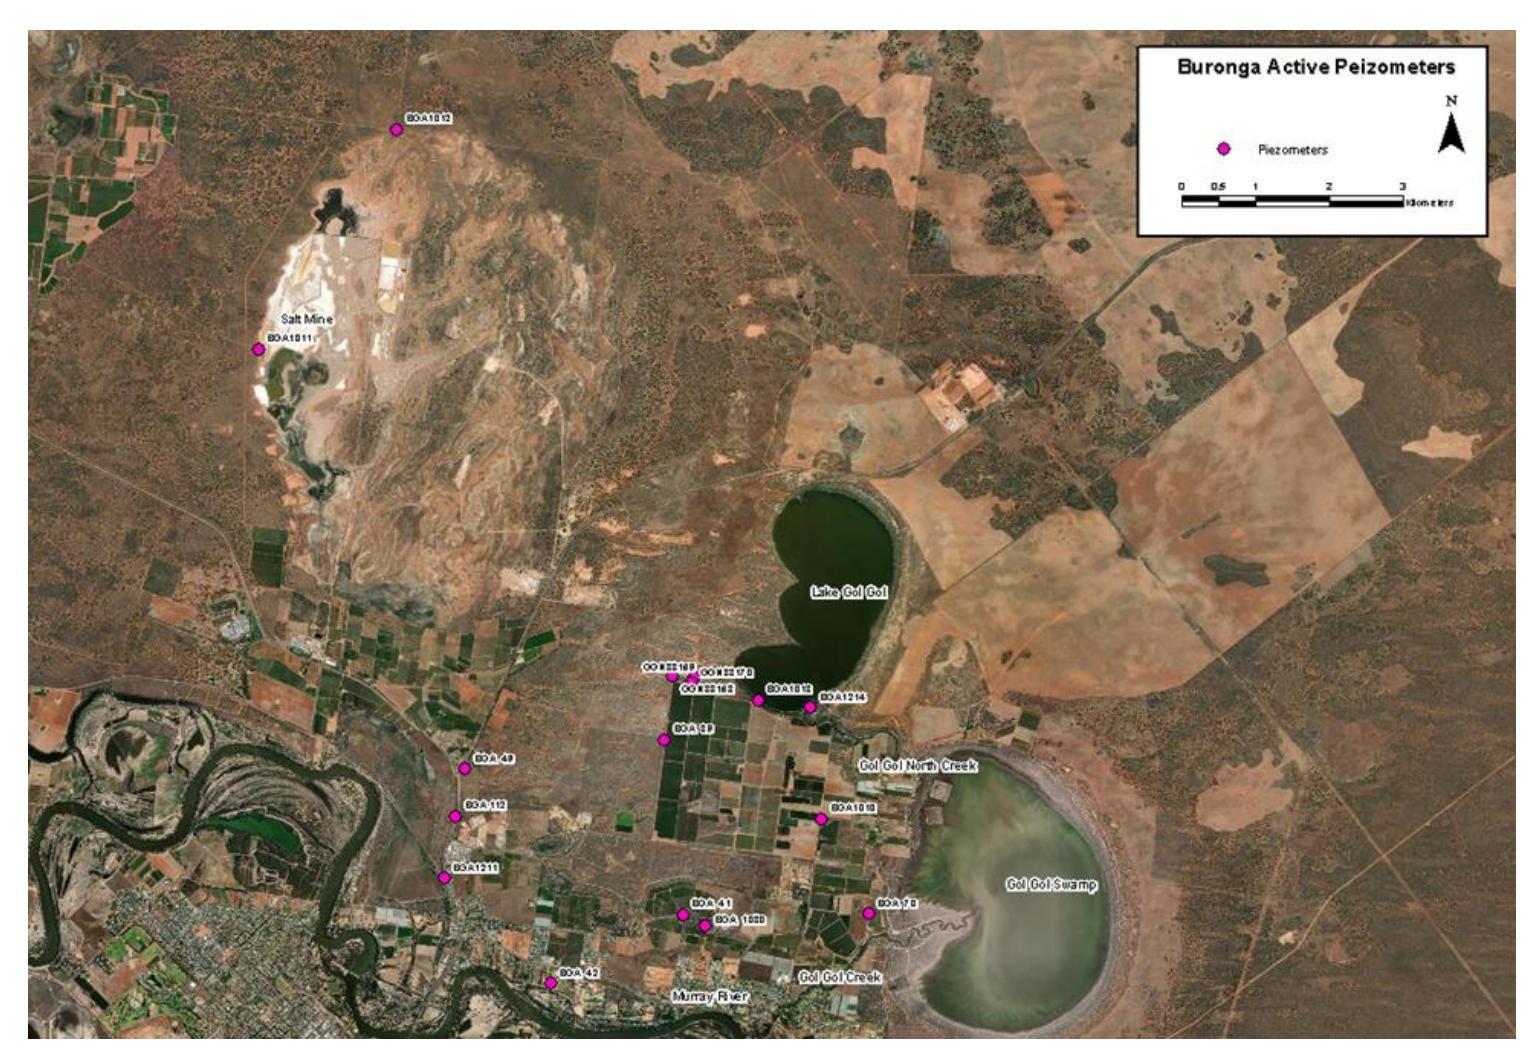
Location of Active Buronga Piezometers:

Map of groundwater depth below natural surface @ 2M contour intervals and including first 1M. Dry/destroyed piezometers are not used for constructing contour lines.

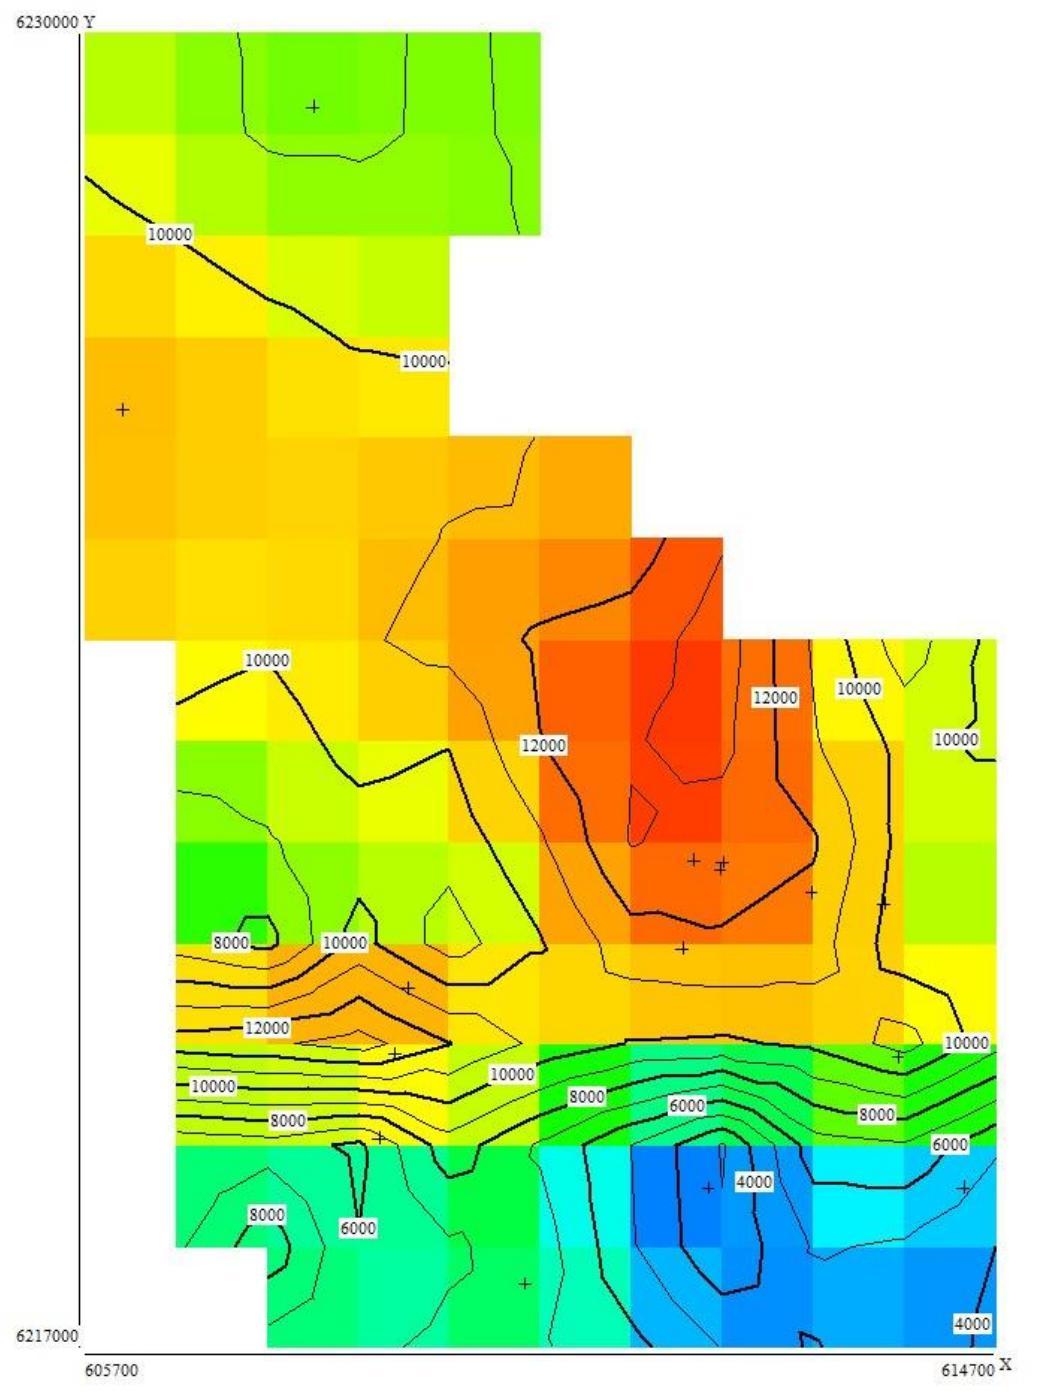
Buronga Salinity Contours (µ/Siemens):

Groundwater salinity @ 0-2000, -5000, -10,000, -20,000, -30,000, -40,000 micro-Siemens/cm contours:
